**DATE:** September 18, 1970  
**TO:** Owners and Operators of Yankee Aircraft  
**SUBJECT:** Spinner/Back Plate Inspection  
**MODELS AFFECTED:** AA1-0001 thru 0216, 0218 thru 0253, 0255 thru 0263, 0265 thru 0315, 0317 thru 0334, 0336, 0338, 0339, 0341 thru 0344, 0346 thru 0349, 0351, 0353 thru 0359, 0362 thru 0366, 0368, 0373, 0375, 0376, 0380, 0382, 0383, 0385 thru 0390, 0392, 0394 thru 0406, 0411, 0413, 0415 and 0416.

SERVICE BULLETIN NO. 119

SERVICE BULLETIN NO. 119  
[Supplement No. 1]

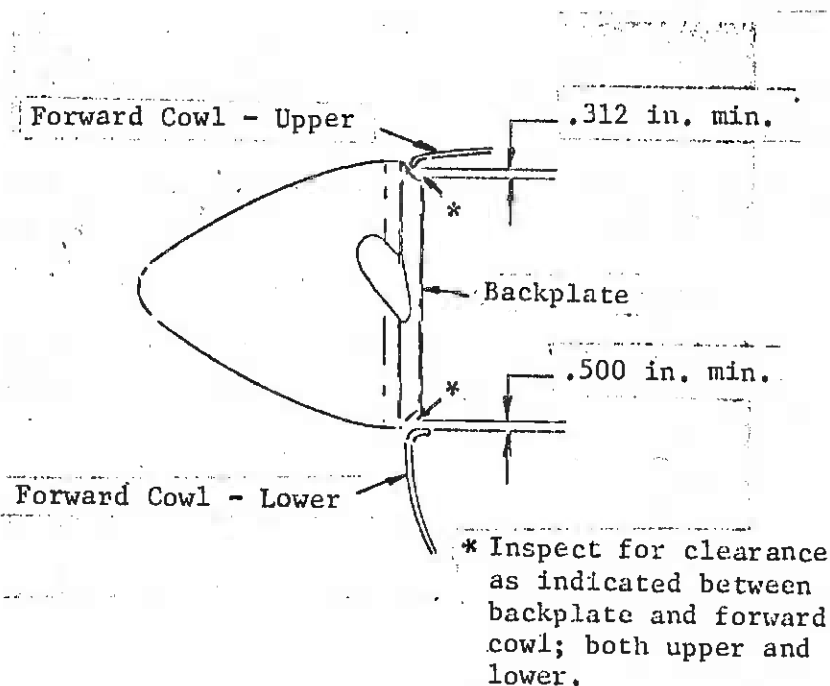
Figure 1. Back Plate and Forward Cowl Clearance

1. Inspect the static clearance between back plate and forward cowl as shown below. If clearance is insufficient, correct per instructions in Service Kit No. SK-109 (copy attached).

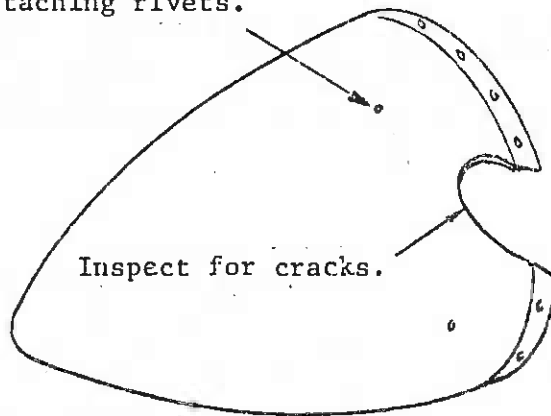
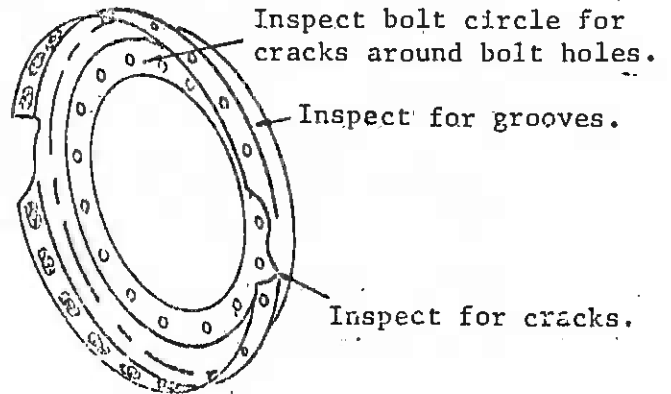
Figure 2. Spinner and Back Plate Inspection.

2. Remove the spinner, propeller, and spinner back plate. Inspect the spinner and back plate for cracks and deep grooves in the areas shown below.

Inspect spinner bulkhead for loose attaching rivets.

Inspect for cracks.

Inspect bolt circle for cracks around bolt holes.

Inspect for grooves.

NOTE: In addition to visual inspection, it is recommended that dye penetrant be used to insure that no cracks are present.

3. If no cracks are found or grooves do not exceed .015 in. in depth the spinner/back plate may be reinstalled after completion of modifications as shown in Service Kit No. SK-109. If cracks are noted in either the spinner or back plate, the cracked unit must be removed from service.

4. Inspect attachment of bulkhead located in the forward end of the spinner for loose or working rivets (See figure 2 above)
