TO: Owners and Operators of Yankee Aircraft

SUBJECT: Nose Gear Strut Inspection

MODELS AFFECTED: AA1-0001 thru AA1-0432. All spares stock of P/N 702057-501 and 702057-503 strut assemblies shipped from the factory before July 1, 1970.

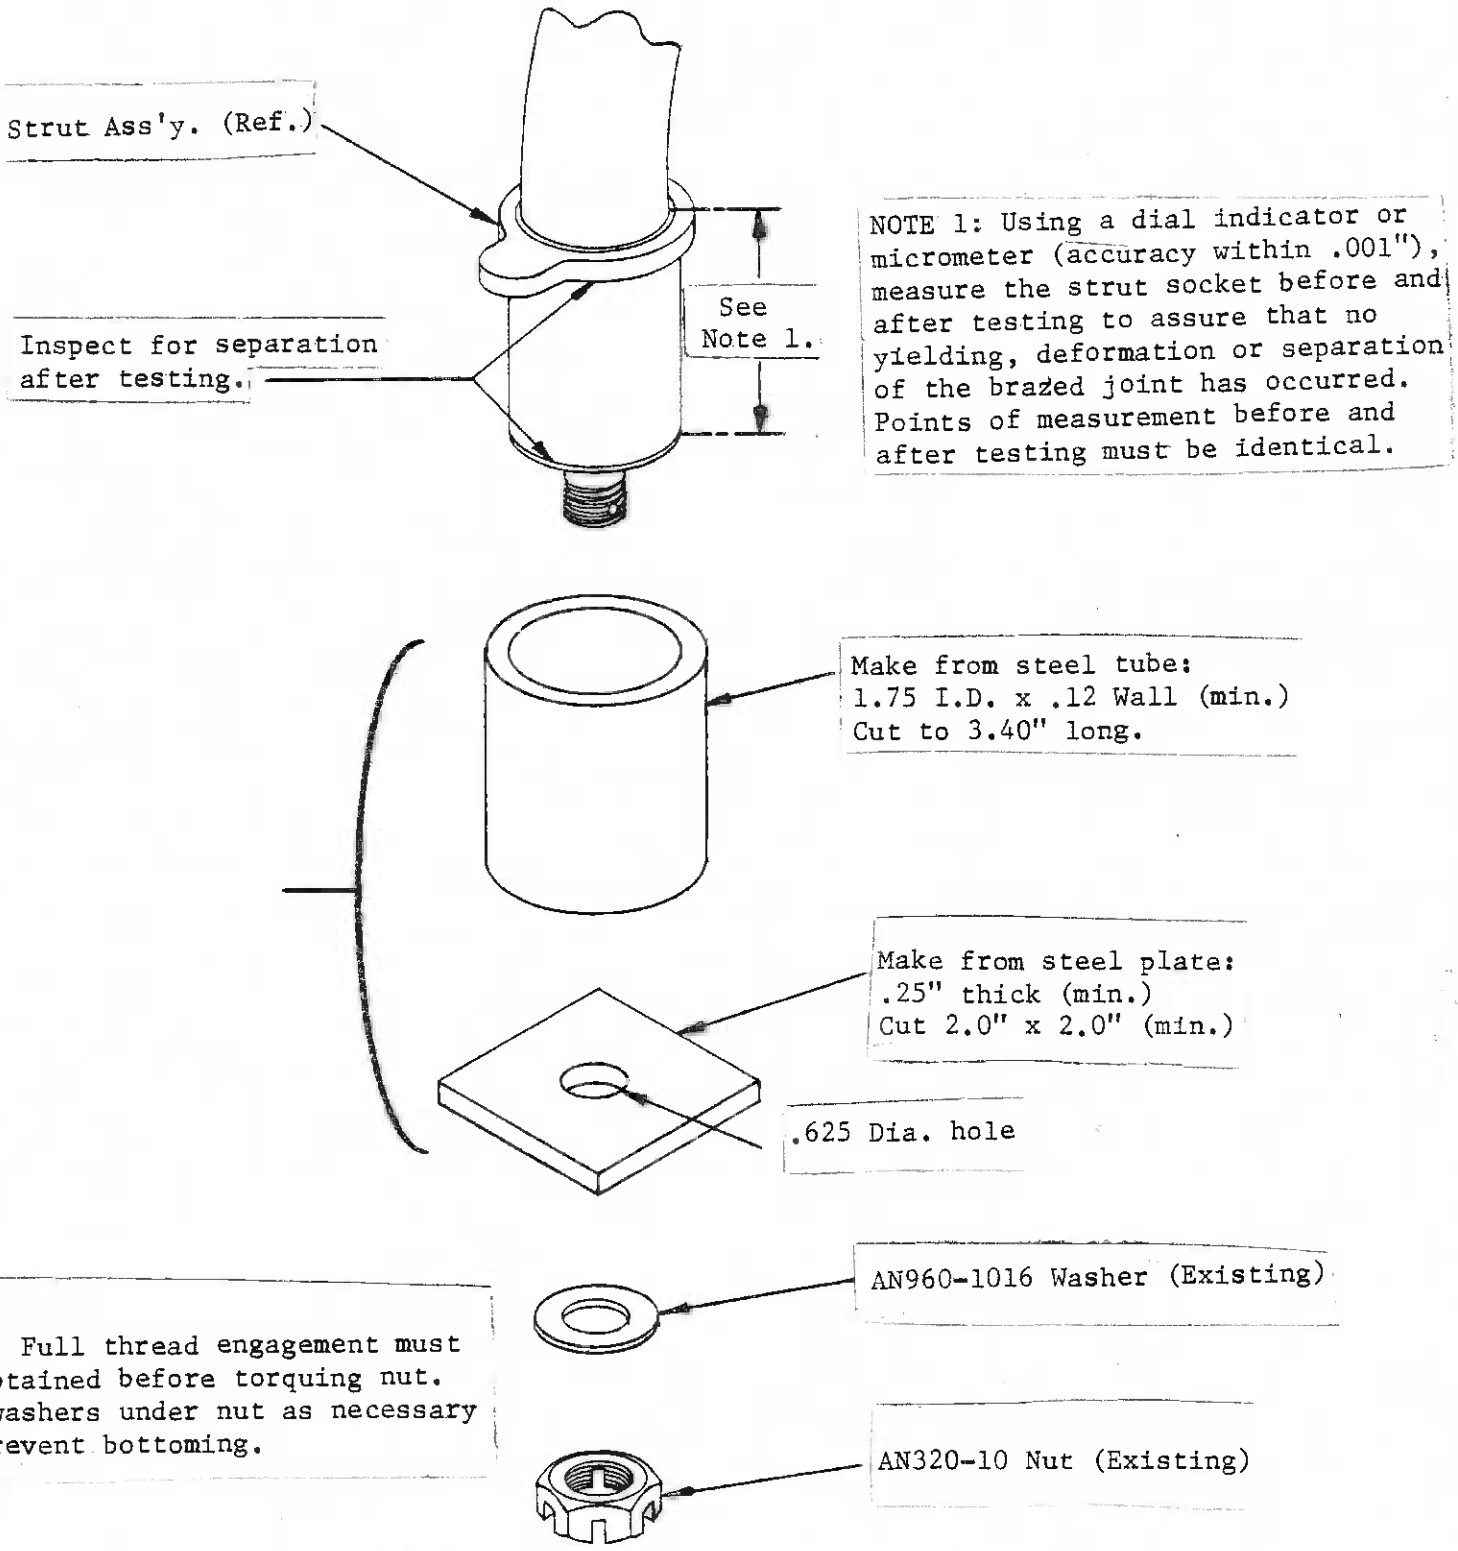
FIGURE 1. Assembly of Test Fixture

Field reports indicate the nose gear strut socket assembly may be defective in the area of the brazed joints. To confirm the structural integrity of the strut assembly, the following inspection and testing procedure must be followed within 10 hours of operation or sooner at the owner's discretion.

1. Remove the nose gear fork assembly and "O" ring noting sequence of assembly of washers. Do not misplace thrust washer located between strut socket and fork. See Note 1, Figure 1.
2. Install test fixture as illustrated. Torque nut to 550 to 600 in. lbs. (46 to 50 ft. lbs.).

NOTE: The fork is installed using an AN960-1016 washer. This washer must be used between the fixture plate and nut as shown. Lubricate strut threads, washer and nut with engine oil prior to assembly.

3. Remove test fixture and inspect the strut socket assembly brazed joints as shown in Figure 1. If there is any evidence of difference in measurement before and after test, the strut must be replaced. See Note 1, Figure 1.
4. To insure that drain hole in bottom of strut is unobstructed, insert a .12" dia. drill at least 2.0 inches into hole.
5. Reinstall "O" ring, lubricate strut socket, fork bearing and washers with MIL-G-7711 grease or equivalent and install fork assembly and attaching hardware exactly as removed (Ref. Service Manual page 4-3).
6. Tighten nut until a 10-13 lb. force along axle center line is required to rotate fork. Install cotter pin and recheck force required to rotate fork.
7. Make entry in aircraft log book stating Service Bulletin No. 121 complied with. Complete and mail attached Service Reply Card.
