Service Bulletin No. 155
FAA DOA EA-4 Approved

Date: July 30, 1976
Subject: Bondline Protection

Serials Affected:	AA1, AA1A's	0001 & Sub.
	AA1B	0001 thru 0641
	AA5's	0001 & Sub.
	AA-5A	0001 thru 0173
		0176 thru 0196
	AA-5B	0001 thru 0309
		0311 thru 0324

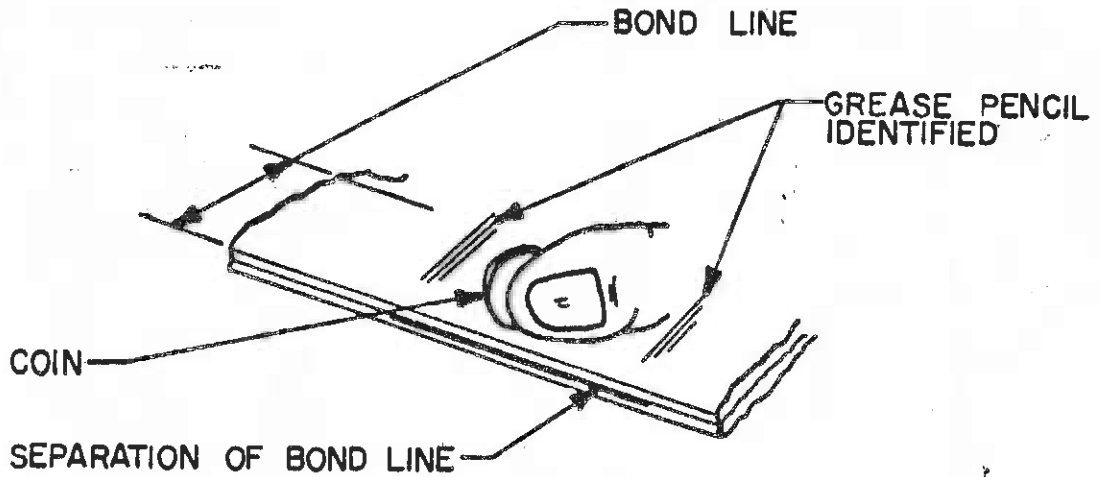
BOND LINE SEPARATION DETECTION METHOD

- A. Carefully scan the edges of all joints in a well lighted hangar or outside in daylight to determine the existence of hairline cracks between two layers of bonded metal. Figure 1 shows the appearance of this condition. Identify the location of any cracks with a grease pencil as shown in Figure 1.

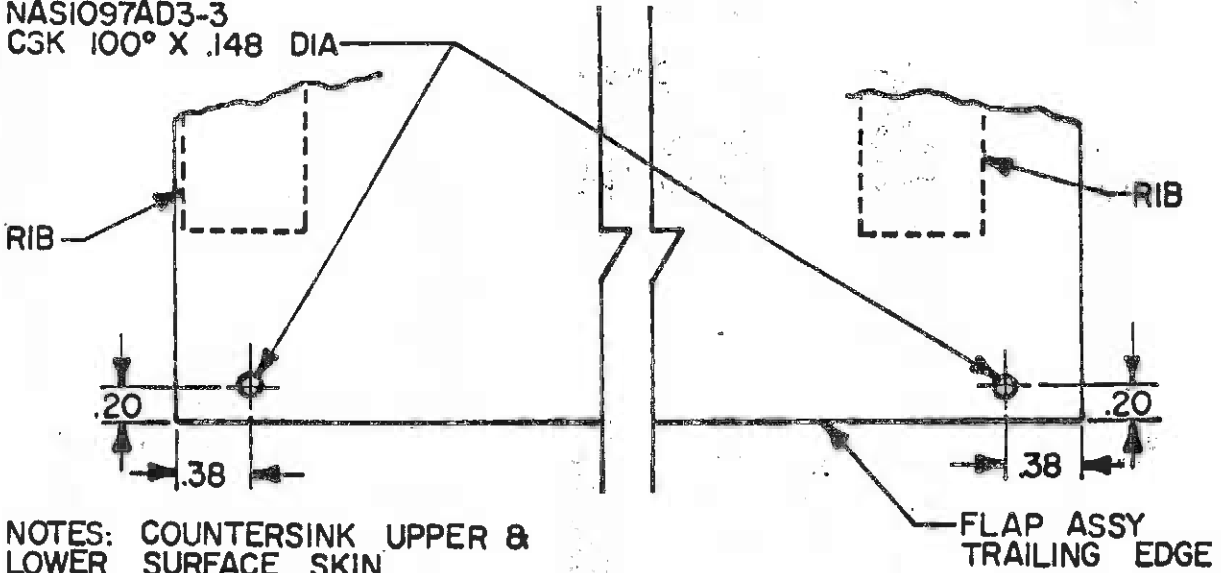
FIGURE 1

TYPICAL FLAP ASSY REWORK - ALL MODELS
 LH SHOWN - RH OPPOSITE

- E. Flap Rework - AA1 0001 and Sub., AA1A 0001 and Sub. and AA1B 0001 - 0579.
 1. Drill .097 - .102 Dia. Hole in outboard and inboard ends of flaps. (See Figure 1). Countersink holes 100° x .148 Dia. Both sides of hole. Care should be used when countersinking, so as not to take out too much material.
 2. Install NAS1097AD3-3 Rivet, wet with zinc chromate primer (MIL-P-8585). Rivet shall be flush both sides.

- F. Flap Rework - AA5 0001 and Sub., AA5A 0001 - 0179 and AA5B 0001 - 0293.
1. Drill .097 - .102 Dia. Hole in outboard and inboard ends of flaps. (See Figure 1). Countersink holes 100° x .148 Dia. both sides of hole: Care should be used when countersinking, so as not to take out too much material.

.097-.102 DIA
 NAS1097AD3-3
 C3K 100° X .148 DIA
