American General Aircraft Corporation

CRITICAL SERVICE BULLETIN

SB No. 183

SUBJECT: PARKER HANNIFIN WHEEL AND BRAKE " MASTER CYLINDERS"

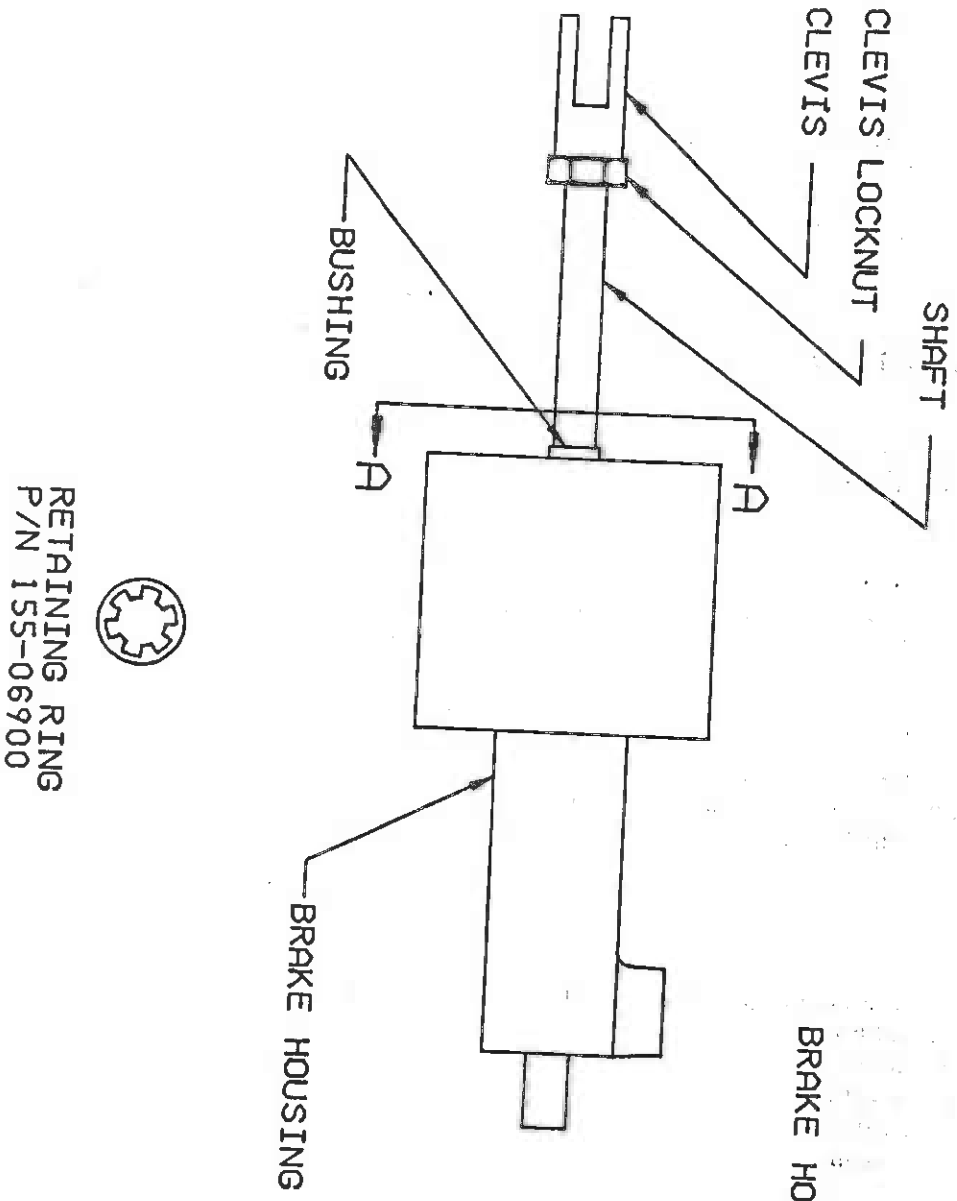
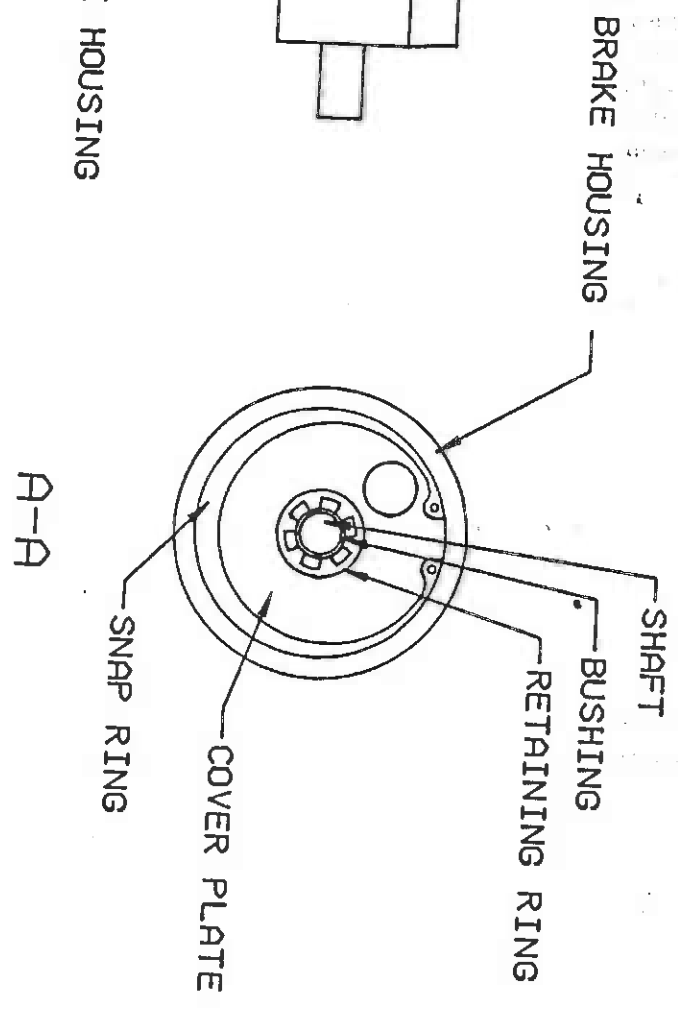
FIGURE 1

We have received reports of loss of directional control during ground taxiing on some of the above mentioned aircraft due to a locked or partially locked brake cylinder. This can occur if the guide bushing in the cover plate of the Parker Hannifin Wheel and Brake master cylinder (P/N 10-35) becomes loose and drops below the cover plate when the brake is actuated. The guide bushing may become wedged between the cover plate and the piston which can prevent the piston from returning to the up position when the brake is released. This condition can cause the aircraft to turn in the direction of the malfunctioning brake.

1. Prepare the aircraft for safe maintenance.
2. Remove the right and left master cylinders in accordance with the AA-5 series Maintenance Manual and the AG-5B Supplement Chapter 32-4-2.
3. Inspect the piston shaft guide bushing in the cover plate for security and wear. (Reference FIGURE 1)
4. If the inspection above reveals that the clearance between the guide bushing and the piston shaft is in excess of .015 inch, or the guide bushing can be rotated in the cover plate, the cover plate assembly must be replaced.

In order to prevent loss of directional control while taxiing due to a locked or partially locked brake, install the 155-06900 retaining ring as follows:

1. Remove the clevis and clevis lock nut from the piston shaft. Note the location of the clevis for reinstallation.
2. Install the retaining ring P/N 155-06900 by sliding the retaining ring (with the inner beveled teeth up) over the piston shaft and simultaneously pulling on the shaft and pushing on the retaining ring to force the ring over the bushing. Make sure that it is on as far as possible. (A "C" channel installation tool would be helpful in this task)
3. Reinstall the lock nut and clevis to its original location.
4. Reinstall the master cylinder in accordance with the AA-5 Series Maintenance Manual and the AG-5B Supplement Chapter 32-4-2.
5. Record compliance with this Service Bulletin in the aircraft log and return the aircraft to service.
6. Complete the attached compliance card and mail to:
