# SERVICE BULLETIN

## SB-194

SUBJECT: **CONTROL COLUMN BEARING LUBRICATION**

MODEL / SERIALS AFFECTED: AG-5B 10201 through 10251

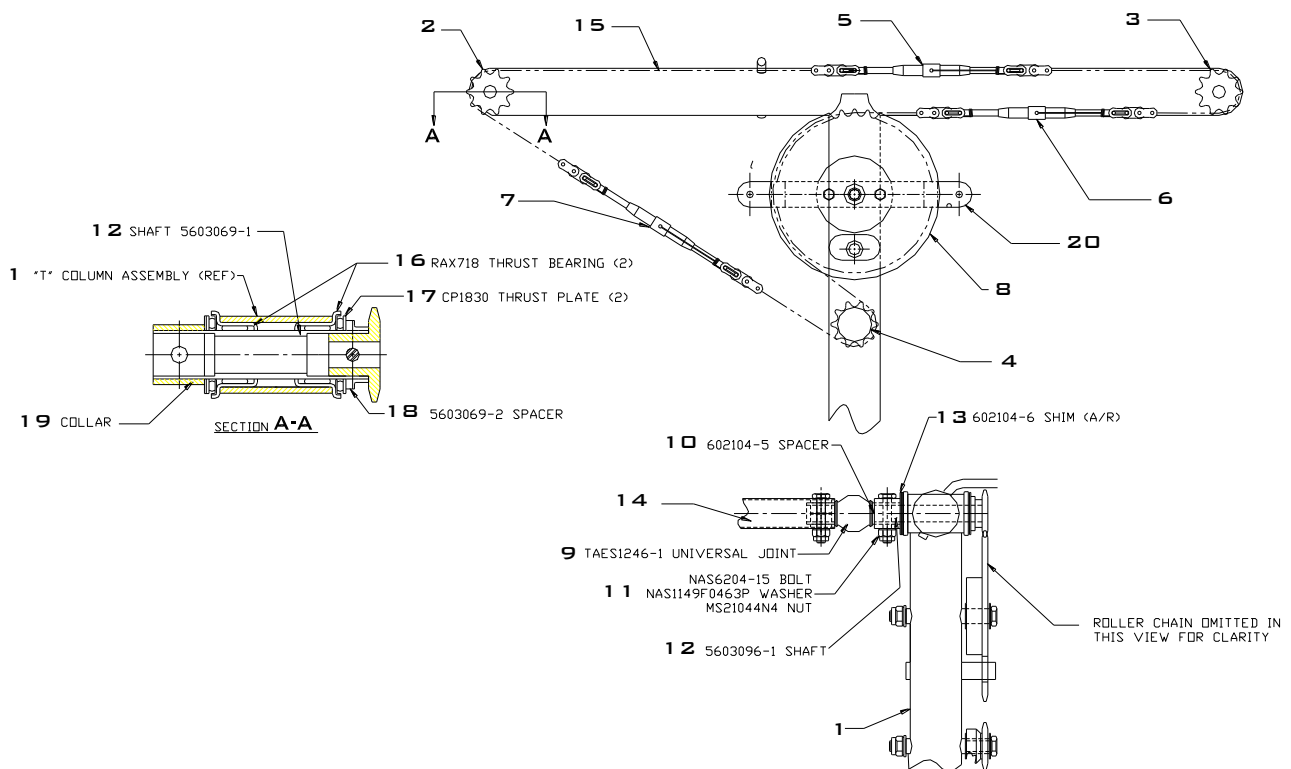
**FIGURE 1**

We have received a report of aileron control binding caused by failure of one or more of the four RAX718 Thrust Bearings installed in the 5602104-504 Control Wheel Column Assembly. The cause of the bearing failure was determined to be the absence of lubrication in the bearing. It is suspected that there may be additional aircraft in the above serial number range that had the RAX718 bearings installed without lubrication during the manufacturing process. If left undetected and not corrected, this condition could lead to the binding of the bearings and loss of aileron control, resulting in possible loss of controlled flight.

##### **B. Thrust Bearing Removal (Ref. Figure 1 and Tiger Aircraft AG-5B Maintenance Manual Chapter 27 )**

- (1) Loosen turnbuckle (5) and remove chain (15) from sprockets (2) and (3).
- (2) Remove nut, washer, and bolt (11) and remove spacer (10) then slide universal (9) aft until the universal is clear of the "T" column.

- (3) Grasp sprocket (3) and pull shaft (12) from control column (1). Shims (13) and thrust plate (17) will separate from the shaft.
- (4) Remove thrust plate (17) and spacer (10) from shaft (12).
- (5) Pull thrust bearings (16) from control column (1).
- (6) Repeat this procedure for the opposite side.

- (1) Inspect the bearings for the presents of grease. If the bearing are dry (no grease), install new RAX718 bearings and new shaft (12) P/N 5603069-1 as described in (D.) below.
- (2) If grease is present, use mineral spirits, to wash all grease from the needle and thrust bearings.
- (2) Inspect bearings for excessive wear, damage and freedom of movement. Replace if defective.
- (3) Use a clean lint free cloth saturated with mineral spirits to remove grease and foreign material from the bearing races.
- (4) Inspect the races for excessive wear or damage and replace if defective.
- (5) Pack the thrust bearings with MIL-PRF-81332 grease.

### D. Reassemble "T" Column (Reference FIGURE 1)

- (1) Place spacers (10) and thrust plate (17) on shaft (12).
- (2) Install thrust bearings (16) in control column.
- (3) Slide shaft (12) through thrust bearings (16) and install thrust plate (17), shims (10), and collar (19) on shaft (12). Align holes in collar (19) and shaft (12).

- (4) Place spacers (10) in end of universal (9) such that holes align, then insert universal (9) into the end of shaft (12).
- (5) Align holes in universal (9) and shaft (12) and secure with bolt, washers, and nuts (11). Torque to standard value per Chapter 91 of the AG-5B Maintenance Manual.
