American Aviation Corporation
318 Bishop Road Cleveland, Ohio 44143

SERVICE KIT NO. SK-110

DATE: June 7, 1971
TITLE: Cabin Floor Honeycomb Repair
SERIALS AFFECTED: AA1-0001 thru AA1-0457 and AA1A-0001 thru AA1A-0123
WEIGHT AND BALANCE CHANGE: Negligible

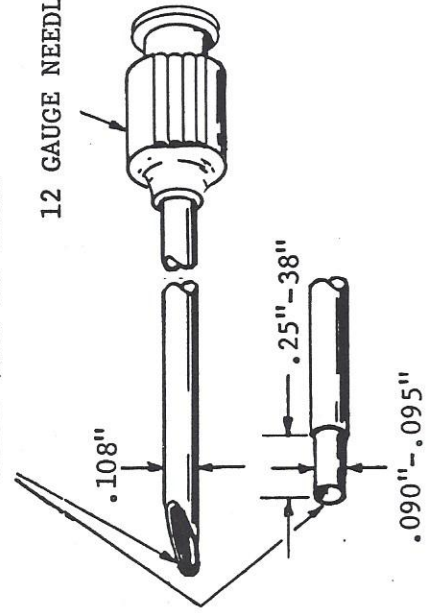
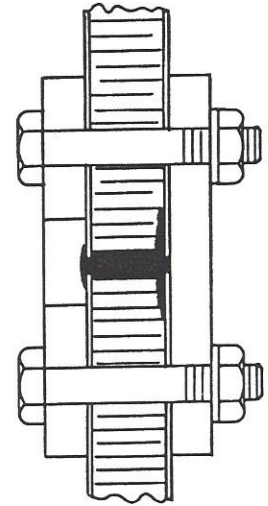
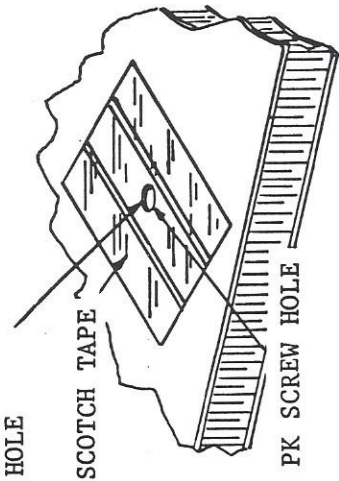
FIGURE 1. CABIN FLOOR HONEYCOMB REPAIR

This kit covers repair of delamination of the honeycomb cabin floor caused by water ingestion around the PK screws that attach the kick pads, console, and carpet retainer strips to the floor. If the accumulated water freezes, minor delamination of the honeycomb bottom skin may result. Drilling holes through bottom skin per Service Letter No. 71-5, eliminates this condition and must be accomplished before repair is begun.

4. Fabricate plates from 1/4" aluminum or 1/8" steel stock as shown on figure 1 (2 for each hole being repaired). See figure 1A for plate dimensions and hole locations.

5. Place 3 strips of scotch tape over top of each PK screw hole (first strip centered over hole, 2 outer strips overlapping) as shown in figure 1B. Punch hole in scotch tape same size as screw hole.
6. Position the top plate with the center hole located over PK screw hole being repaired. Using the plate as a guide, drill two bolt holes (.250 dia.) perpendicular, through honeycomb and bottom skin. Apply a coating of paste wax to two 1/4"-28 bolts 1 1/2" long and insert bolts through top plate and honeycomb. Install bottom plate and tighten nuts finger tight.
7. Modify the 12 gauge needle supplied with kit as shown on figure 1C.
8. Mix the A-1333-B adhesive one-to-one and using the syringe and needle supplied in kit, inject the adhesive into the top PK screw holes. Use care not to over-pressurize this area.

9. Tighten plate bolts to 40 in.-lbs. torque.
