American Aviation Corporation  
318 Bishop Road Cleveland, Ohio 44143

SERVICE KIT NO. SK-114

DATE: March 29, 1972  
~~TIME:~~  
 SUBJECT: Front Seat Improvements  
 SERIALS AFFECTED: AA5-0001 thru AA5-0089  
 WEIGHT AND BALANCE CHANGE: Negligible

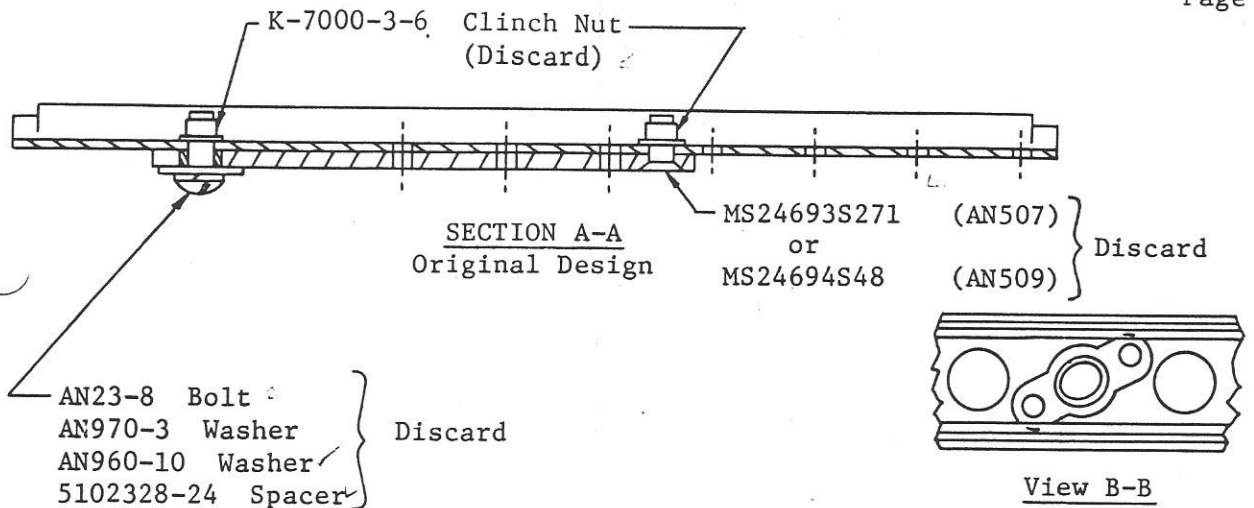
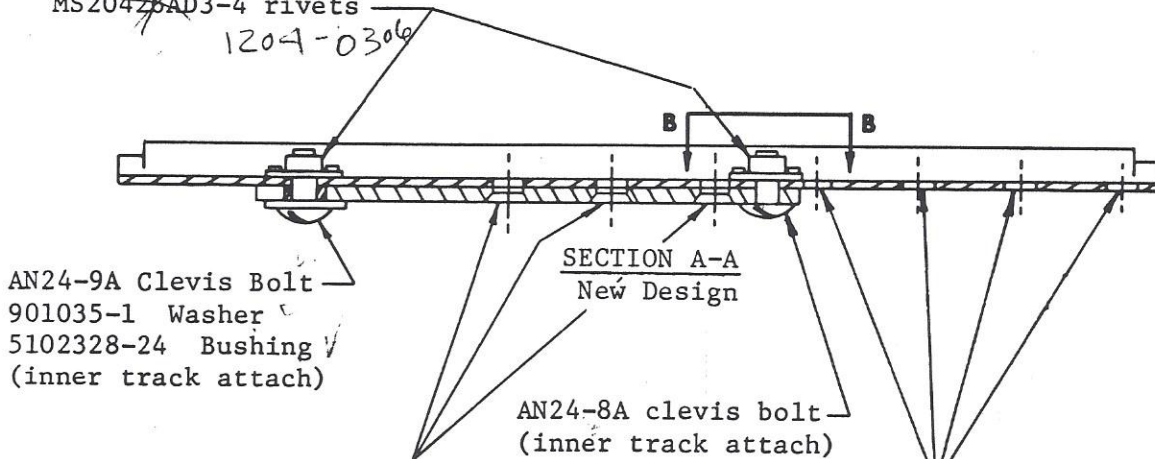
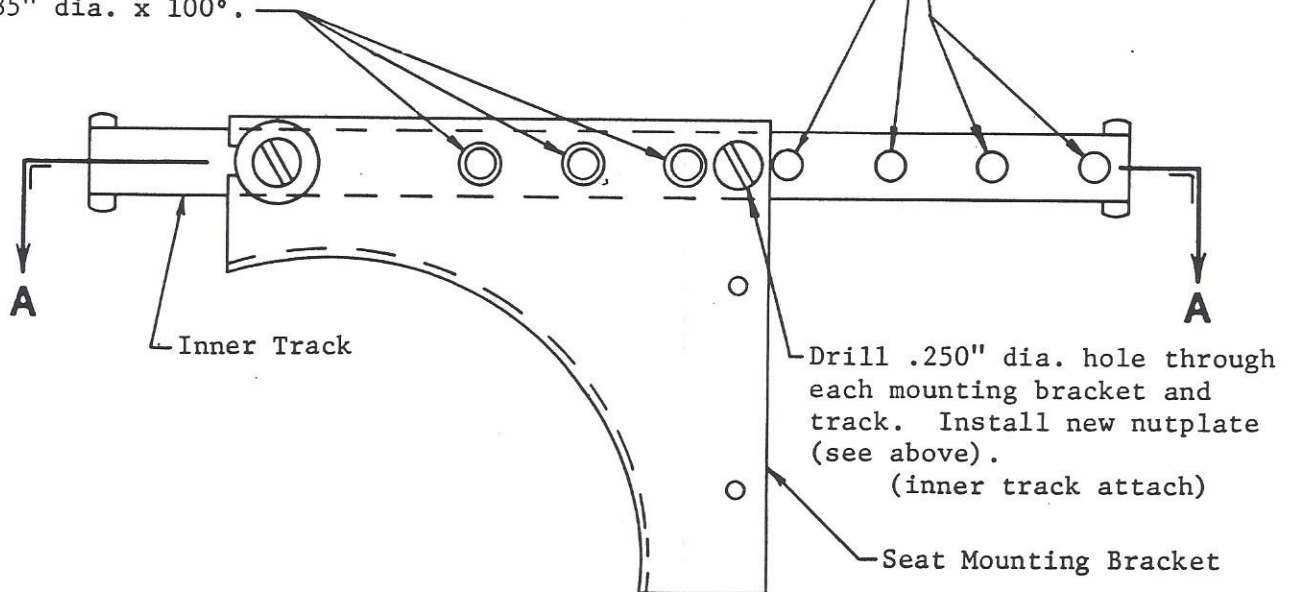
FIGURE 1.

This modification incorporates recent production improvements which make the front seat latching more pronounced and positive and strengthens the seat support attachment.

SEAT SUPPORT BRACKET AND INNER TRACK MODIFICATION AND ASSEMBLY  
L.H. ASSEMBLY SHOWN, R. H. OPPOSITE

4. Modify the inner tracks by enlarging the .203" dia. lock pin holes to .312" dia. (7 holes per track) (Note: this already incorporated on aircraft serial no. AA5-0064 and up). Remove (and discard) the clinch nuts, drill out holes to .250 dia. and install NAS697A4 nut plates and MS20426AD3-4 rivets supplied with kit. (See Fig. 1)

10. Cycle seat adjustment mechanism to confirm full engagement and release of the locking pins at the full forward and full aft track positions.
11. On the seat mounting brackets (still mounted to center spar in the aircraft), drill the existing .203" dia., (3) lock pin holes to a .312" dia. and countersink .385" dia. x 100° on the inside surface (to each seat), of each bracket. (Note: this already incorporated on serial no. AA5-0058 and up). This helps guide the lock pins in place. Drill the existing forward seat rail attach bolt hole in each bracket to .250" dia. (Fig. 1)

Install NAS697A4 nutplates with  
MS20426AD3-4 rivets

Drill .312" dia. through mounting  
brackets and inner track. Counter-  
sink 3 holes in each bracket to  
.385" dia. x 100°.

Enlarge ALL lock pin  
holes to .312" dia. in  
inner track.

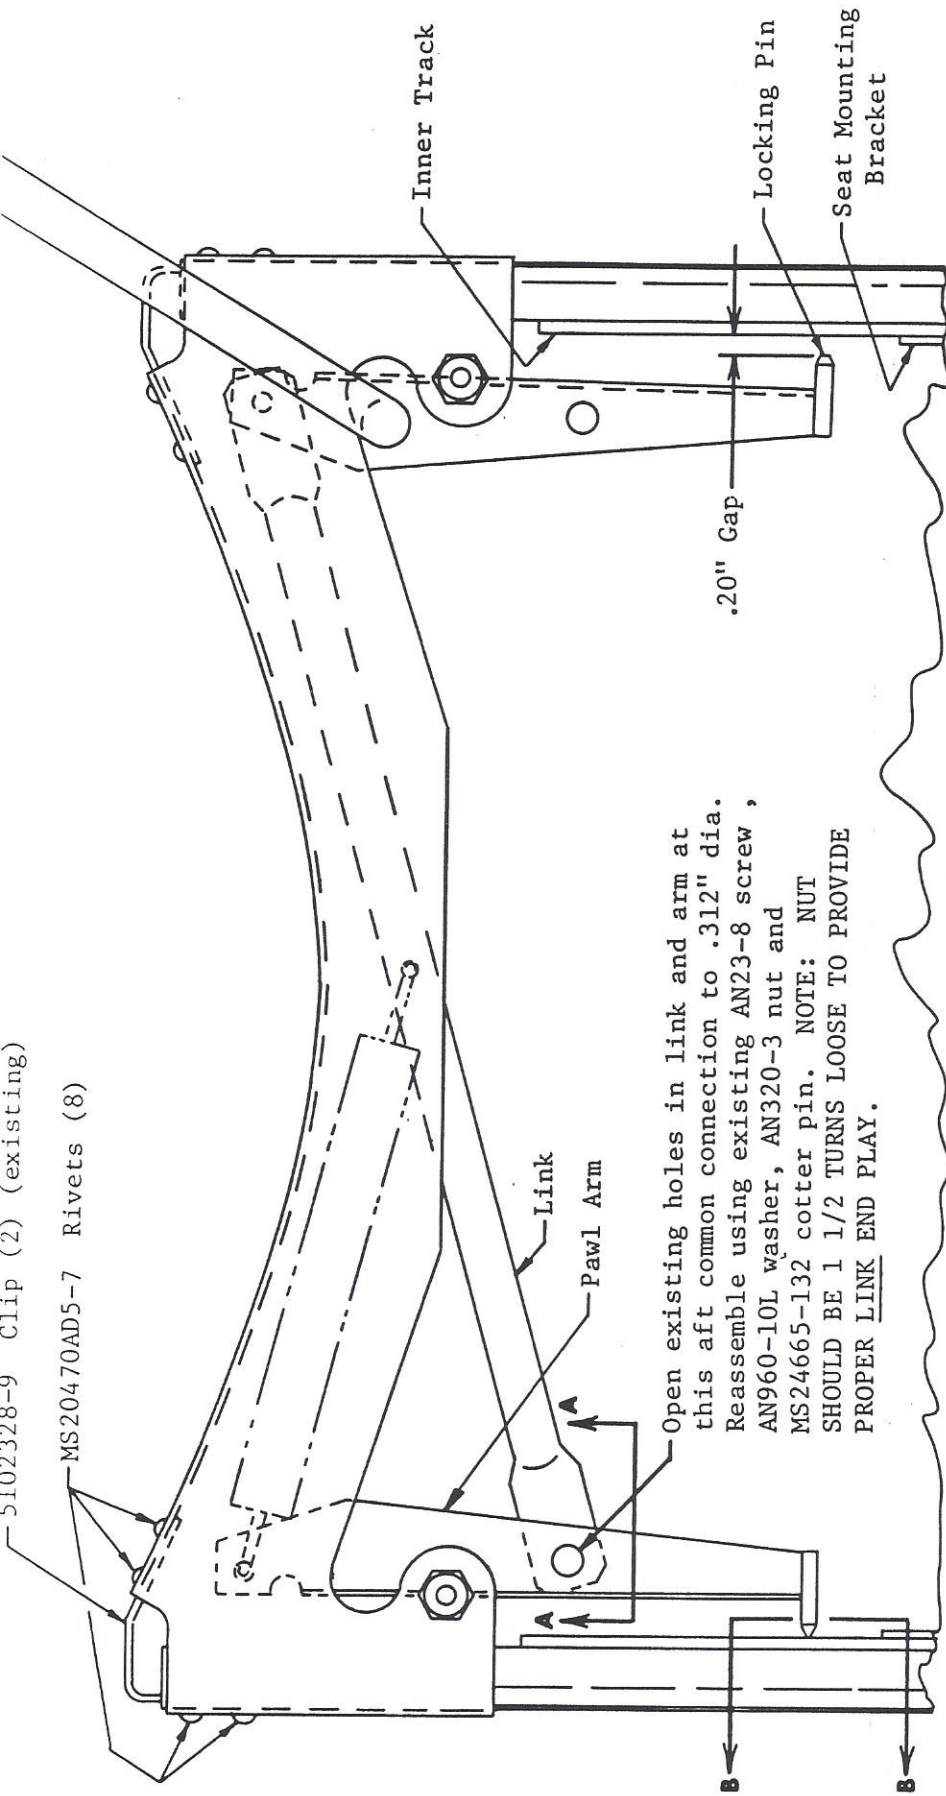
FIGURE 2.

BOTTOM OF L.H. (PILOT) SEAT  
LOOKING UP

5. Install the new 5102328-24 bushings, 901035-1 washer and AN24-9A clevis bolts, from the Service Kit, at the aft track mounting holes.
6. Open up hole in link and pawl arm (aft common connection) to .312" dia. and reassemble connection using original hardware (See Figure 2). Be sure the link is installed on the side opposite the pawl arm flange as shown in Figure 2, Section AA. Nut should be 1 1/2 turns loose to provide proper link end play.

Open existing holes in link and arm at this aft common connection to .312" dia. Reassemble using existing AN23-8 screw, AN960-10L washer, AN320-3 nut and MS24665-132 cotter pin. NOTE: NUT SHOULD BE 1 1/2 TURNS LOOSE TO PROVIDE PROPER LINK END PLAY.

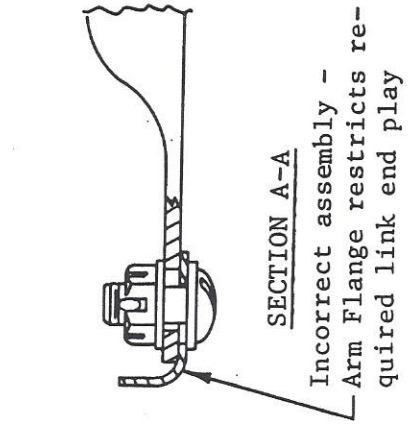
SECTION A-A  
Correct assembly - Link mounted on side opposite arm flange allows maximum end play required for proper latching operation. ELONGATE NEW .312 DIA. HOLE IN LINK IF ADDITIONAL END PL. IS REQUIRED PER PAR. 9.  
Incorrect assembly - Arm Flange restricts required link end play
