SERVICE KIT NO. SK-118-1

Large Pulley Installation - 2-place Control System

AA1-0001 thru AA1-0459, AA1A-0001 thru AA1A-0470 and

AA1B-0001 thru AA1B-0049

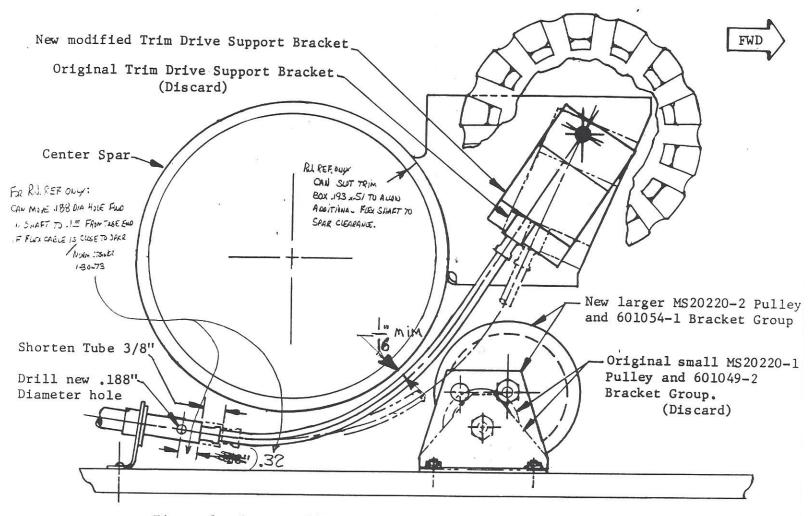
Figure 1. Large Pulley Installation and Trim Drive Modification

This modification covers the installation of larger diameter pulleys in the control system pulley group located under the console just forward of the center spar. This requires installing new larger pulleys, larger group support brackets, a new trim wheel drive support bracket, moving an electrical wire bundle and shortening the trim drive torque tube.

- Disassemble control pulley assembly and reassemble using the large pulleys and the new brackets supplied with kit. Assemble with pulley shaft in the forward bracket holes as shown in Figure 1.

- Reinstall trim drive torque tube in the aircraft, being careful not to rotate 19.
- Install new pulley assembly in aircraft, being sure all control cables are on correct pulley. (See Figure 1.).
