## SERVICE

SERVICE KIT NO. SK-130

Throttle Cable Clamp Modification

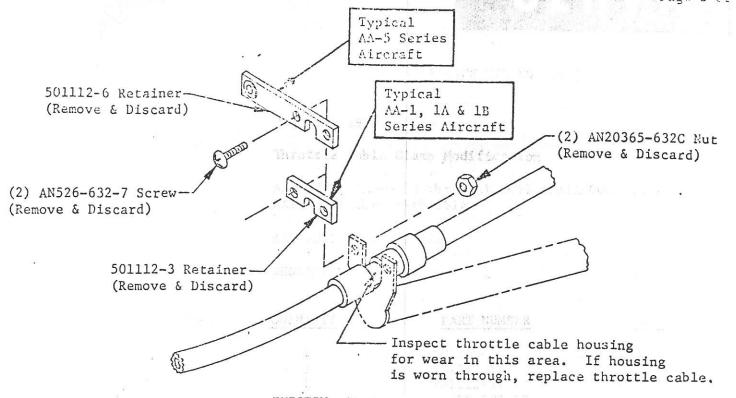
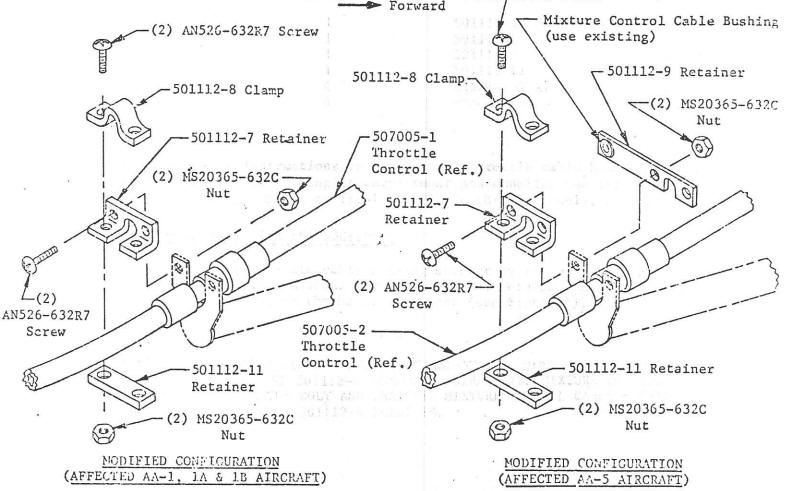
Figure 1. Throttle Cable Clamp Modification CRUMMAN AMERICAN AVIAITON CORPORATION

This Kit provides the instructions to inspect the throttle cable housing for wear at the housing support in the engine compartment and supplies the material required to modify the existing support to firmly clamp the throttle cable housing.

3. Inspect the throttle cable housing for wear in the support area. If the

throttle cable housing is worn through at any area on the locking groove, the throttle cable must be replaced. If replacement is required, see Figure 1 for throttle control part numbers.

Remove the discard the existing screws, nuts, and retainers that attach the throttle cable housing to the housing support (see Figure 1).

- 4. Install the modified retainers and clamp as indicated in Figure 1. On the affected Model AA-5 aircraft, reconnect the mixture control wire to the carburetor and rig per the applicable Service Manual.
- 5. Check throttle and mixture controls for proper travel, security, operating condition and control cushion.
- 6. Install the lower cowl.
