SINGLE ENGINE AIRCRAFT SERVICE KIT NO. 150

SUBJECT: FLIGHT CONTROLS (ATA NO. 27) AILERON,
MODIFICATION OF

August 3, 1979

GULFSTREAM AMERICAN SINGLE ENGINE AIRCRAFT SERVICE KIT NO. 150

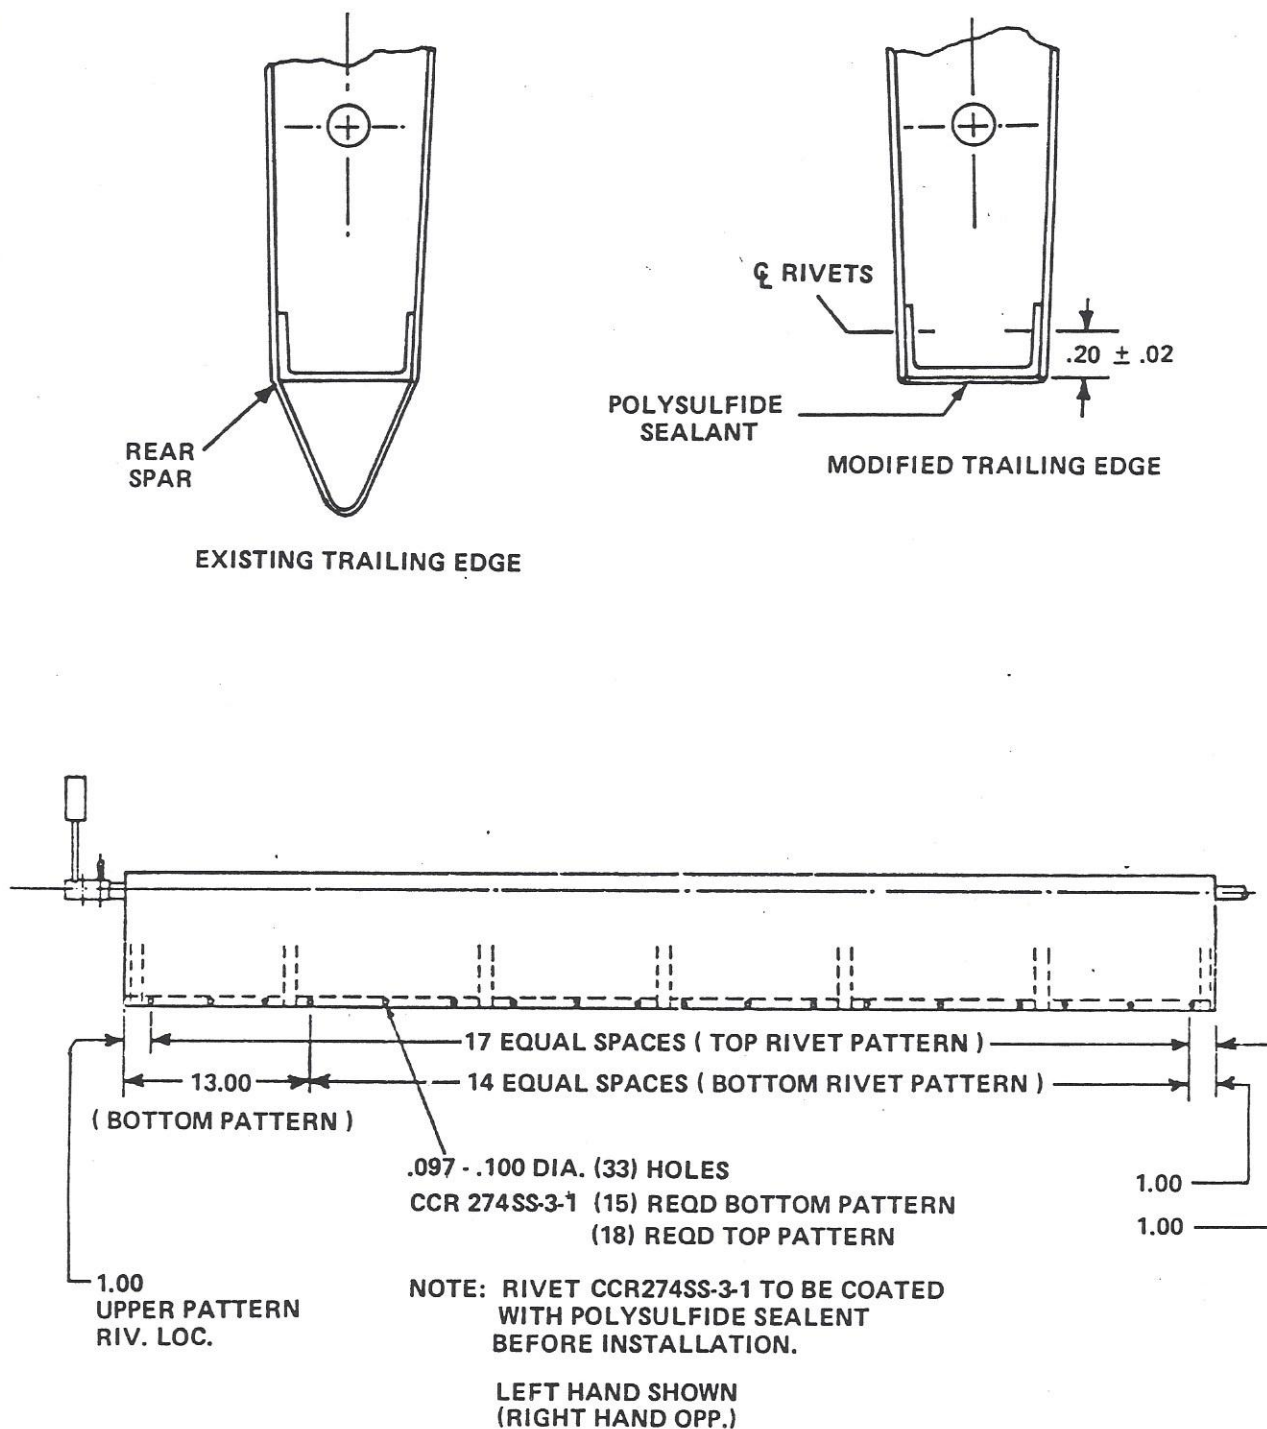
FIGURE 1

PURPOSE/DISCUSSION: The purpose of this service kit is to modify the aileron to prevent possible oscillation during flight.

- A. Prepare the aircraft for safe ground maintenance as follows.
- A-1 Insure that the Master Switch is OFF and all aircraft System Switches are OFF.
 - A-2 Insure aircraft is grounded.
 - A-3 Comply with all safe maintenance practices as recommended in the Maintenance Manual and FAA Regulations.
- B. Rework Instructions
- B-1 Block the ailerons to prevent aileron movement.
 - B-2 Remove the aileron trim tab. Retain for reinstallation. Drill .097 - .100 dia holes in aileron rear spar in-board end and the top outboard end per Figure 1 and install CCR274SS-3-1 rivets. Installation of rivets is to prevent corners from spearating.
 - B-3 Remove aileron trailing edge skin flush with the rear spar on the left and right hand aileron. See Figure 1.

When cutting the trailing edge, make initial cut well away from the bond line and use care on final cut to prevent delamination to bond line. Leave .03 to .05 extention for final filing, to prevent damage to rear spar.

- B-4 Smooth skin edges flush with rear spar, using strokes toward center line or parallel to trailing edge. See Figure 1.

- B-5 Drill .097 - .100 dia holes in top and bottom of the aileron trailing edge as shown in Figure 1.

- B-6 Install CCR274SS-3-1 rivets in the trailing edge of the aileron as shown in Figure 1. Dip rivets in CS3204A2 Polysulfide sealant before installing.

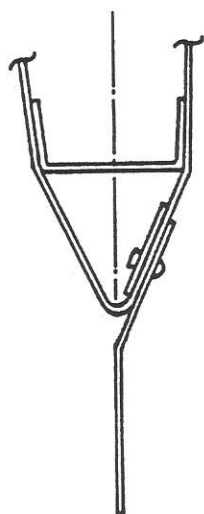
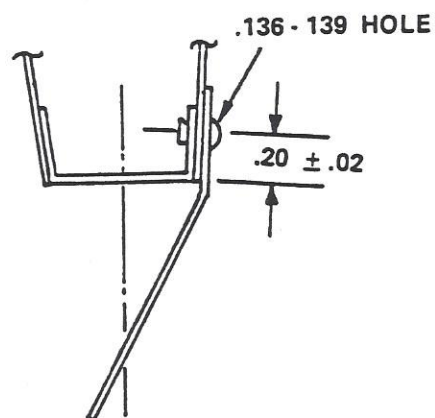
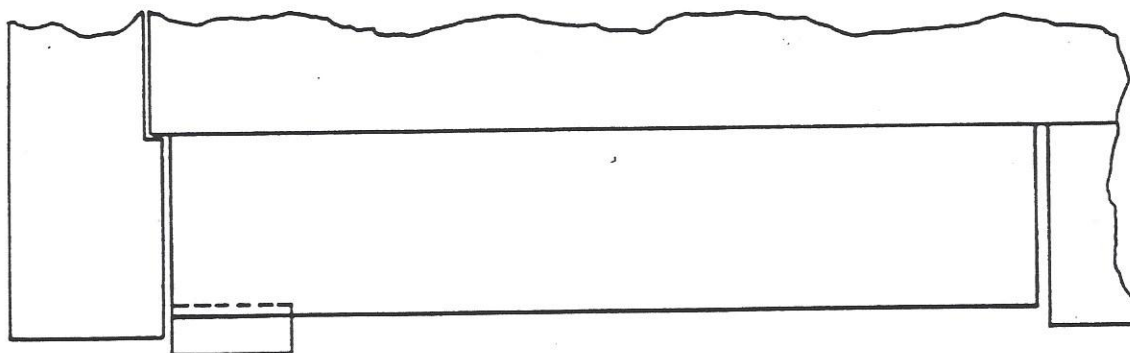
(TYP) TRIM TAB ON
EXISTING AILERON

(TYP) TRIM TAB INSTALLATION
AFTER ALTERATION
TAB INSTALLED
BOTTOM

- B-9 Apply zinc chromate primer to repair area prior to repainting.
- B-10 Turn the aileron trim tab up side down and install on bottom surface as shown in Figure 2 using 1601-0410 rivets.

5202036-1 TAB (REF)
1601-0410 RIVET (7) PLACES
