AMERICAN GENERAL SINGLE ENGINE AIRCRAFT SERVICE KIT NO. 151

Throttle cable support bracket replacement.

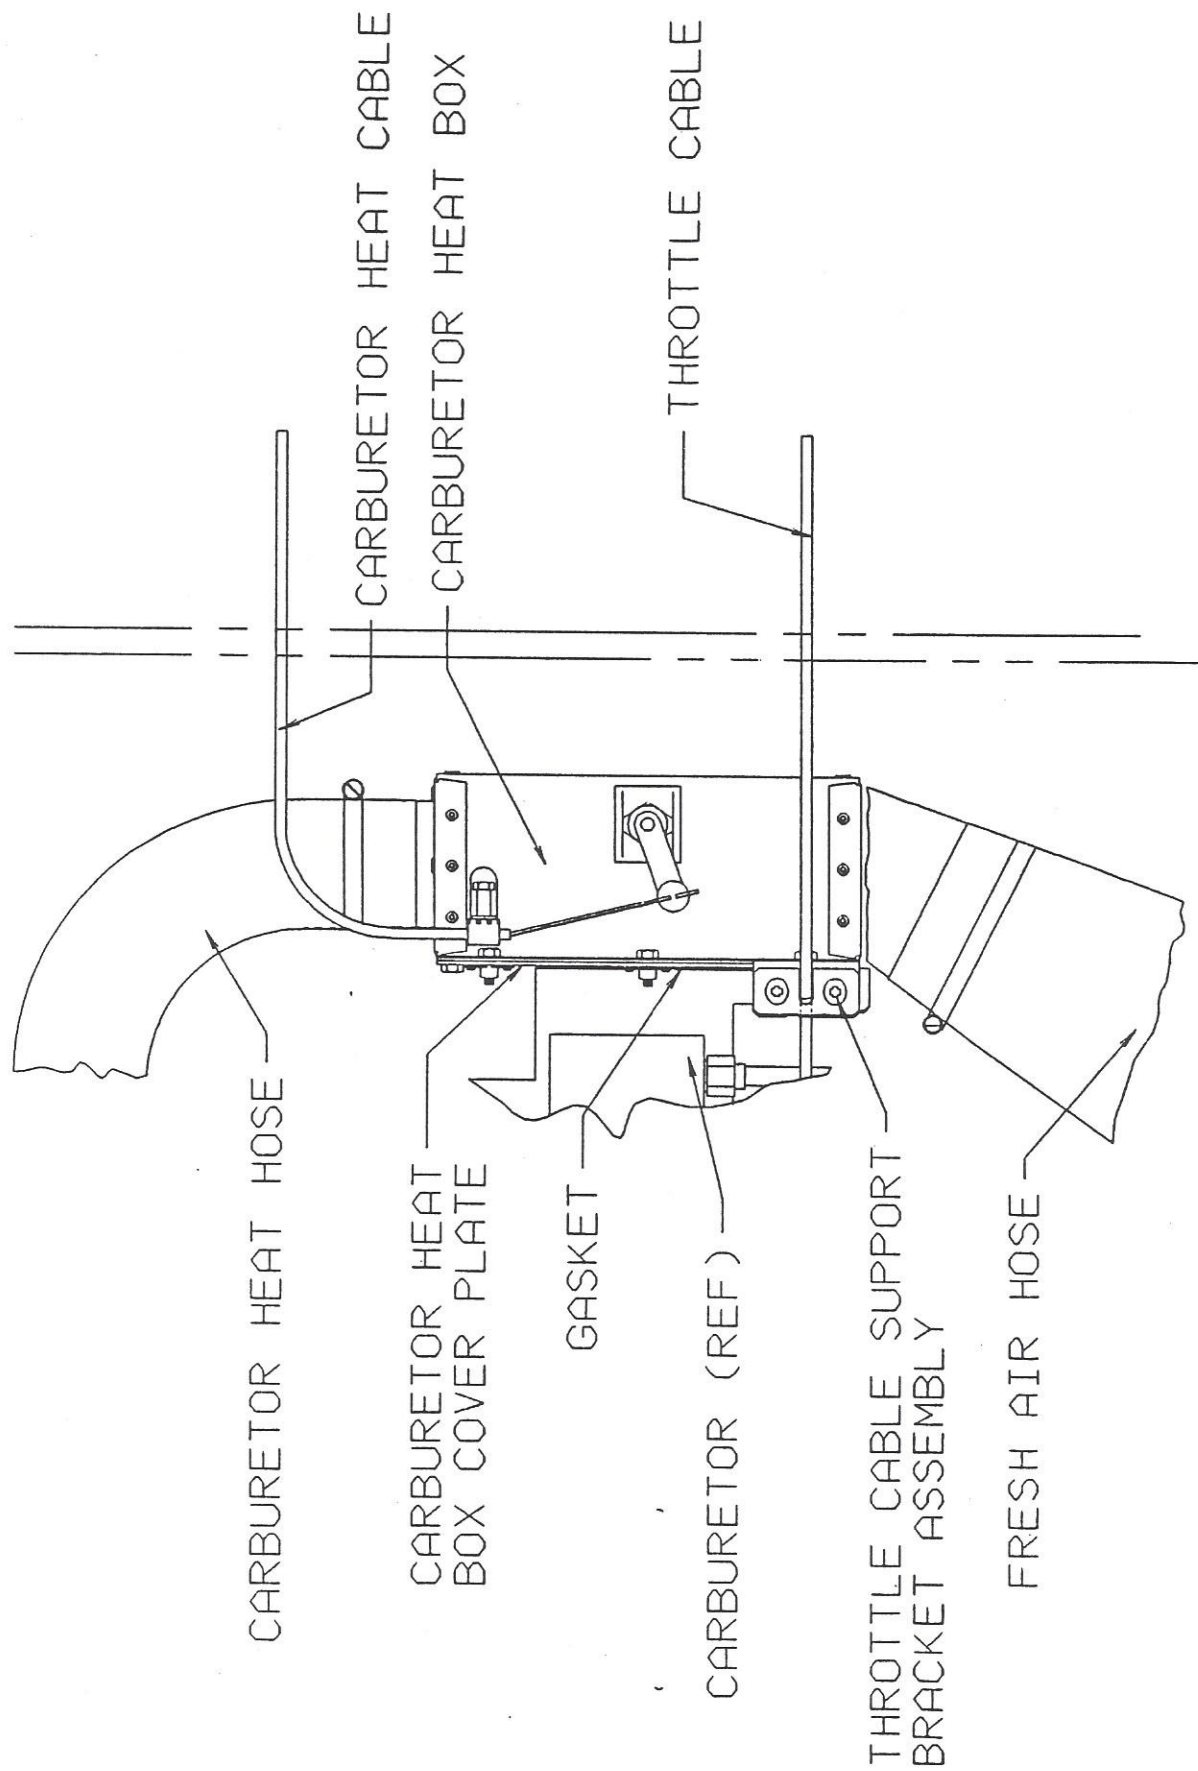
FIGURE 1

The throttle cable support bracket assembly located on the carburetor air box has been found to wear excessively within a short period of time. This wear could cause the cable to come loose from the bracket and possibly result in loss of throttle control.

- B-1 Remove the carburetor heat cable from the carburetor heat box and retain the hardware (see Figure 1).
  - B-2 Remove the throttle cable from the throttle cable bracket assembly (see Figure 1).

- B-3 Loosen the hose clamps that attach the fresh air and the carburetor heat hoses to the carburetor heat box and remove the hoses. Remove the eight bolts that attach the carburetor heat box to the cover plate and remove the box from the airplane (see Figure 1).

- B-4 Remove the four bolts that attach the carburetor heat box cover plate to the carburetor and remove the cover plate and gasket from the airplane (see Figure 1).
