SERVICE LETTER NO. 75-3
"FAA DOA EA-4 APPROVED"

SUBJECT: IMPROVED FRONT SEAT BOTTOM

SERIALS AFFECTED: AA5-0001 thru AA5-0772 and AA5B-0001
thru AA5B-0036

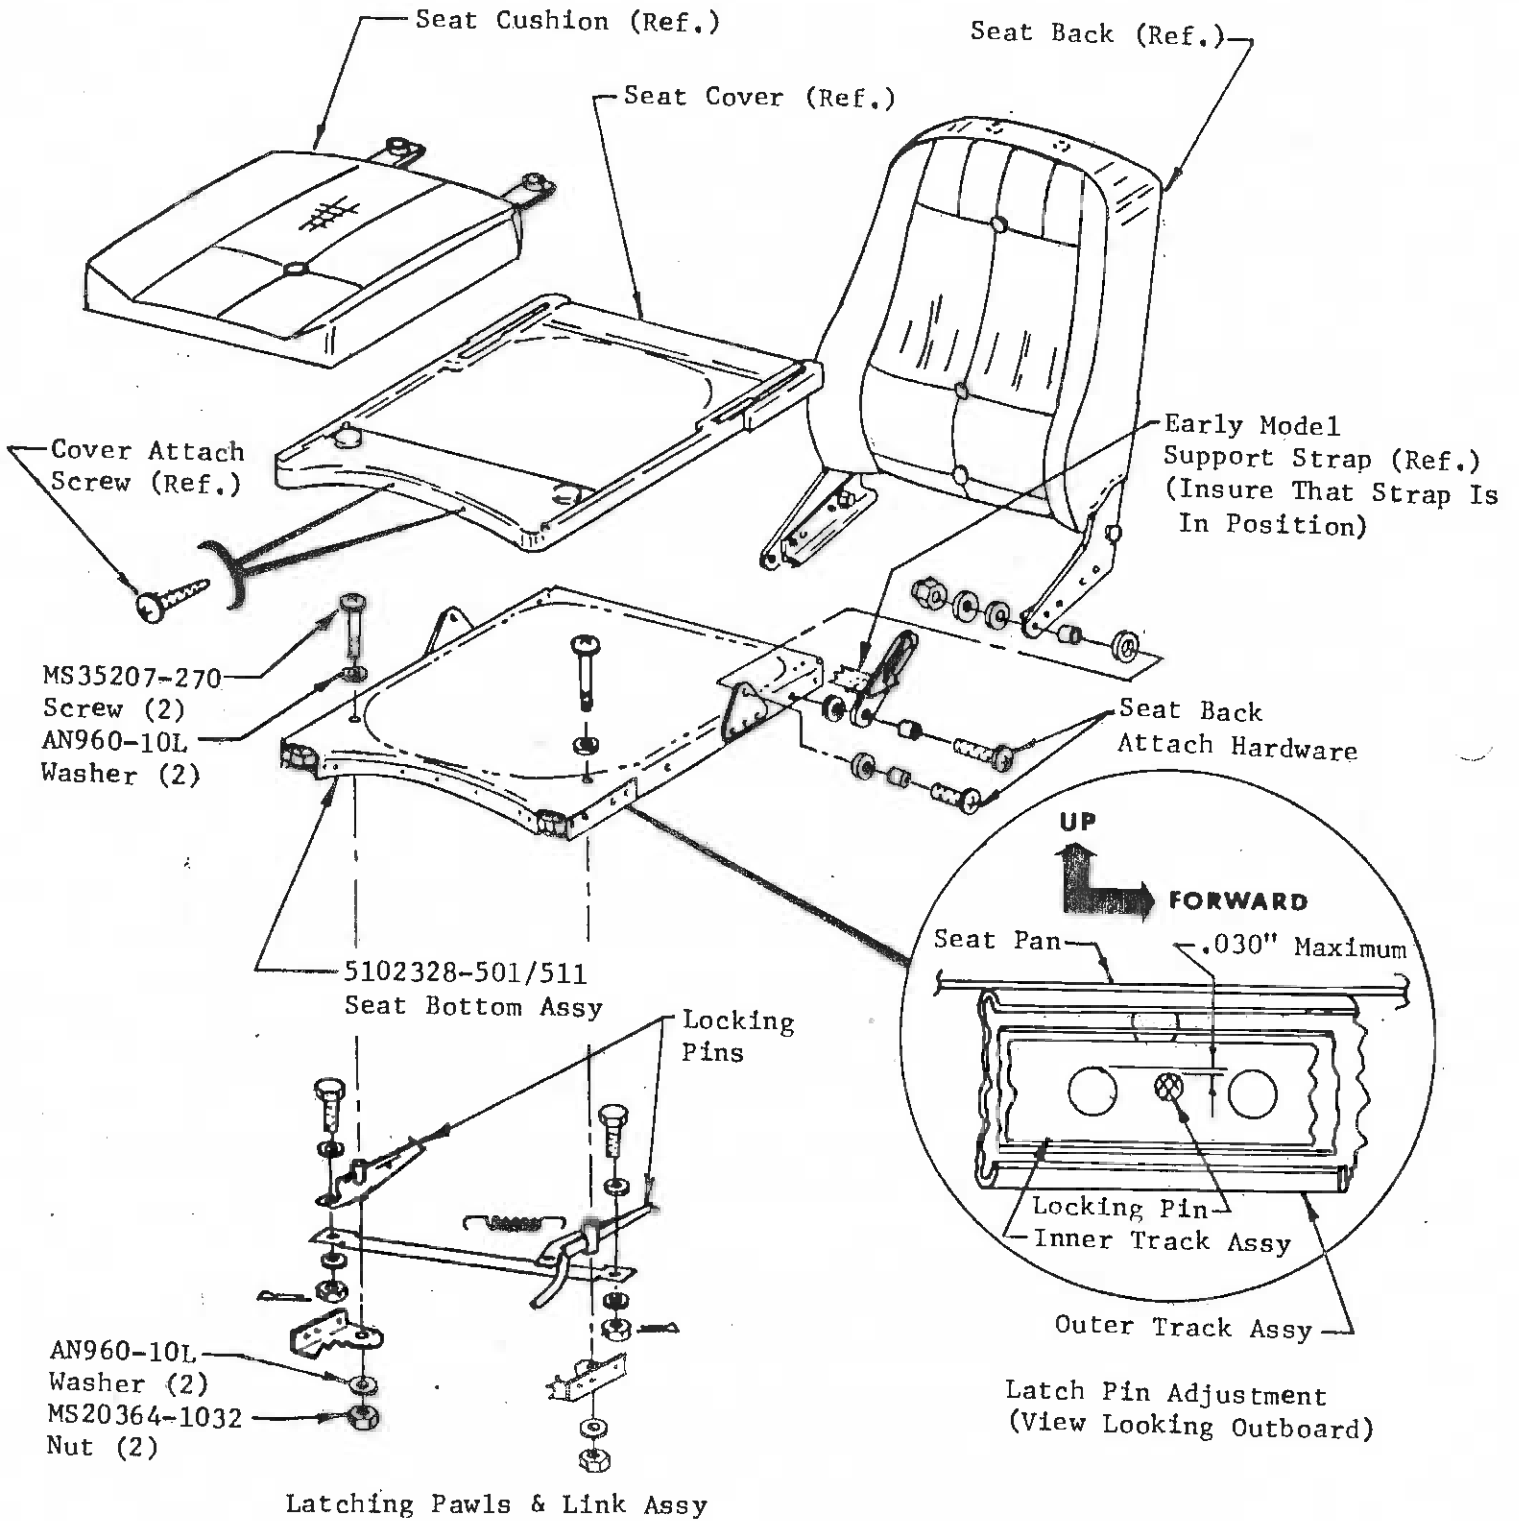
Figure 1. Front Seat Bottom Installation
 (LH Early Model Shown; RH & Late Model Similar)

Recent development efforts have resulted in improvements which increase the strength of the inner and outer front seat tracks. In addition, a design change has been made to the ball retainers that provides for increased ball retention during periods of excessive aft loading.

These improvements prevent binding, allow more pronounced and positive latching and increase the service life of the front seats.

REPLACEMENT INSTRUCTIONS (REFER TO FIGURE 1)

The improved front seat bottoms are a direct replacement for the existing bottoms and include the complete riveted assembly, inner tracks, balls and retainers.

1. Remove both front seats from the aircraft by removing the two forward support bracket to seat rail attach screws and sliding the seat rails aft out of the slot in the support bracket.
2. Remove seat back attach hardware and separate back from seat bottom. Remove seat cover attach screws and separate cover from seat bottom.
3. Remove MS20364-1032 Nuts and MS35207-270 Screws that secure latching pawls to seat bottom and detach pawls and link assembly from existing seat bottom assembly.
4. Install latching pawls and link assembly in new 5102328-501/511 Seat Bottom Assembly using hardware removed in Step 3. Bend both pawl arms so that top of pin is aligned with top of adjustment holes within .030 inches as shown in Figure 1, Latch Pin Adjustment. Lubricate inner and outer tracks with general purpose grease per MIL - G - 7711.

5. Install seat back and cover in the reverse of the removal procedure. Reinstall seats in the aircraft and test for free movement and positive latching in all positions.
