DATE: June 1, 1975

SUBJECT: LANDING LIGHT REPLACEMENT

SERIALS AFFECTED: All Model AA-1 and AA-1A, AA1B-0001 thru AA1B-0550,  
and AA5-0001 thru AA5-0640

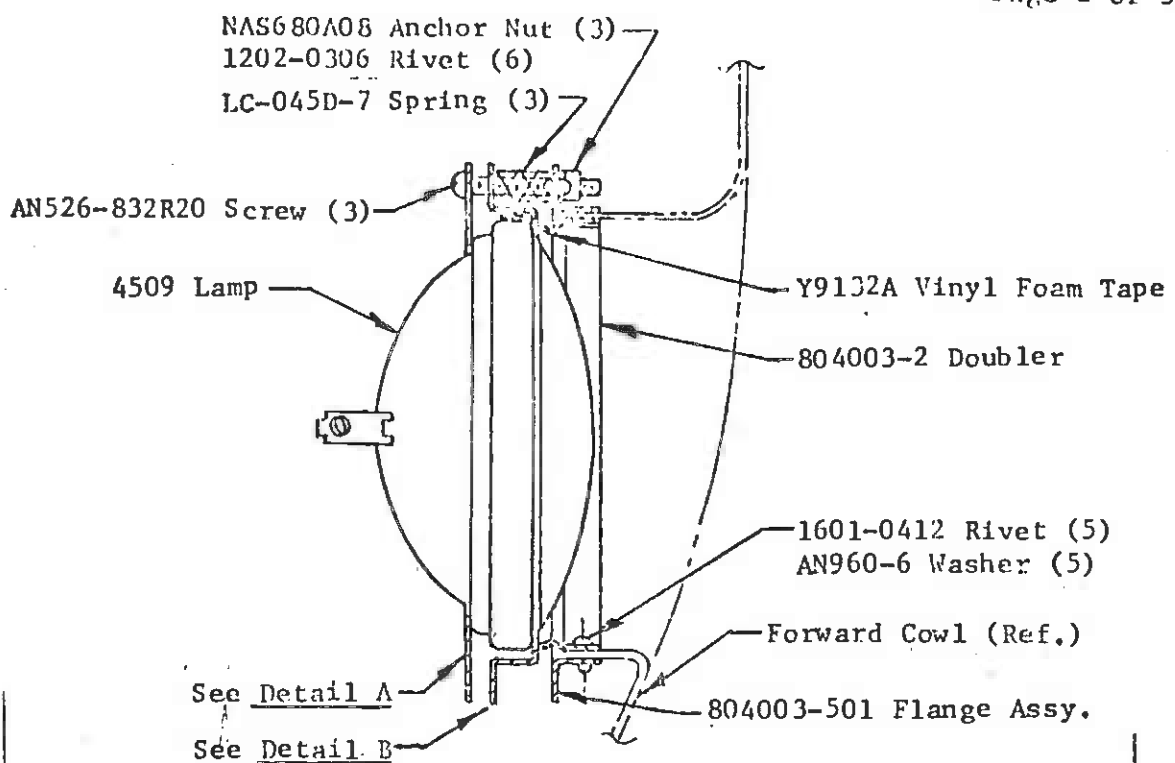
Figure 1: All Model AA-1 and AA-1A;  
AA1B-0001 thru AA1B-0338;  
AA1B-0340; AA1B-0343;  
AA1B-0346 thru AA1B-0370;  
AA5-0001 thru AA5-0640.

The cowl mounted landing light and retainers on the aircraft serials affected, are subject to premature failure if installed improperly and/or nonstandard attach hardware is used for assembly. Therefore, this Service Letter provides lamp replacement instructions, specifies the attach hardware and identifies improvements that may be incorporated.

1. From behind the forward cowl, remove existing lamp and inspect retainer, support and flange assemblies for cracks; screws and anchor nuts for type specified and thread condition; and tapes for deterioration. Replace all items that are worn or damaged.

2. View the intersection of the locating notch and the inside diameter of the 804003-503 Retainer Assembly shown in Detail A. If a sharp corner exists, round off to .06 inch radius.

3. If 804003-5 & -6 Tapes were not provided as original equipment, fabricate tapes out of .06 inch thick vinyl foam tape (single faced) and attach as shown in Details A and B.

4. Subassemble retainer, lamp, support, screws and springs, and loosely attach to forward cowl. Adjust light to lowest position possible by tightening top adjustment screw fully and lower two screws only enough to eliminate gap between lamp and cowl.

5. Refer to applicable Service Manual for final adjustment specifications.
