METAL PROPELLER REPAIR MANUAL

INTRODUCTION

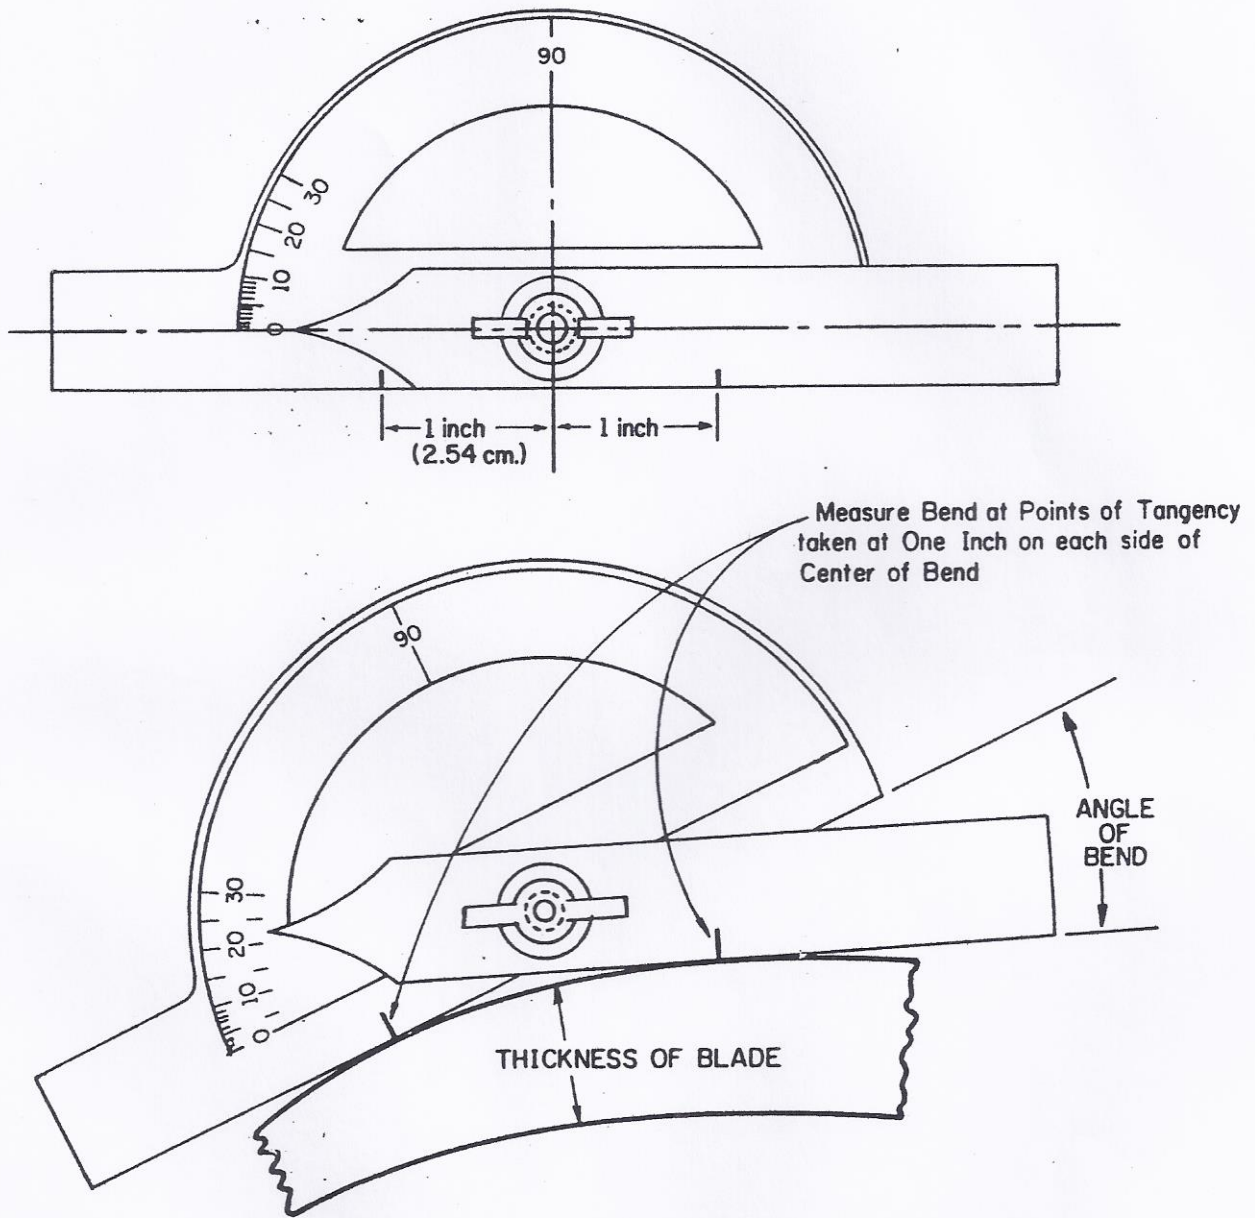
FIGURE 1
MEASUREMENT OF BEND (DEGREES PER 2 INCHES BLADE LENGTH)

When a blade is bent, the bend must be measured by the method shown in Figure 1 of this manual, and compared to the appropriate graph of maximum allowable bend vs. blade radius. Beware of repairing bends which, by the shape of the bend, indicate that the blade may have been pre-straightened to bring it within allowable limits. See A.C. 20-7J (August, 1972).

3. **STRAIGHTENING A BENT BLADE:** If the bend is within allowable limits, this should be the first repair operation. Using a suitable bending tool or repair bench, the blade should be straightened in small increments proceeding from the portion of the bend nearest the hub, where the blade is thicker, outward along the blade until the fairing and appearance of the blade are reasonably good. At this point, the results can be judged by sighting along the blade. Blade contours should flow smoothly from the tip inward, without apparent waves or curvature reversal. The propeller should then be placed on a propeller checking stand, and its face alignment checked by comparing corresponding stations of the repaired blade with those of the undamaged blade.

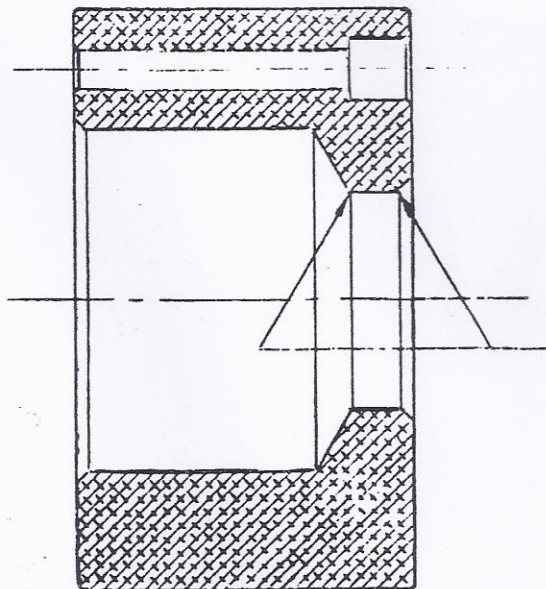
REMOVE PROPELLER AND VISUALLY INSPECT FOR CRACKS ORIGINATING IN PILOT BORE. IN CASE OF DOUBT, ANY OF THE APPROVED METHODS FOR ALUMINUM ALLOY INSPECTIONS MAY BE USED. IF CRACKS ARE FOUND, THE PROPELLER MUST BE RETIRED IMMEDIATELY FROM SERVICE. IF NO CRACKS ARE FOUND, POLISH OUT ANY SCRATCHES IN THE BORE AND BREAK AND POLISH ANY SHARP EDGES APPEARING AT THE FRONT AND REAR CHAMFER OF PILOT BORE. (SEE DRAWING)

WHEN PROPELLER IS REINSTALLED, TORQUE RETENTION BOLTS TO 300 INCH POUNDS.

AFTER COMPLIANCE, PROPELLER SHALL BE REMOVED AND INSPECTED AT EACH ANNUAL INSPECTION OR EACH 100 HOUR INSPECTION, WHICHEVER OCCURS FIRST. PROPELLERS WITH CRACKS MAY BE RETURNED TO THE MANUFACTURER FOR POSSIBLE REPLACEMENT ON A WARRANTY BASIS.

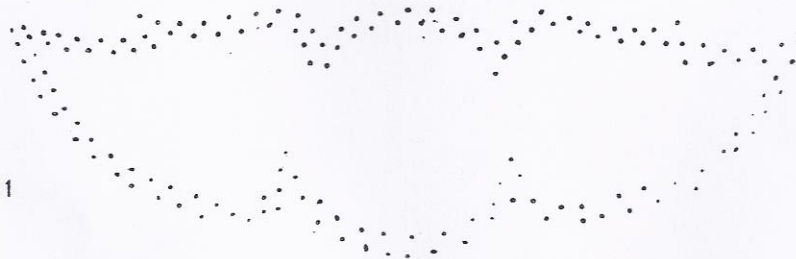
SKETCH #1

Sensenich Propeller Bulletin No. R-10 dated 4 January 1965, required the removal of the mid-blade decal so that the area under and adjacent to the decal could be examined for corrosion pits. These corrosion pits had, in some cases, initiated a fatigue crack which resulted in a failure of the propeller blade. These corrosion pits are clusters of tiny black dots (see sketch #1) which appear most frequently under the narrow black border of the decal.

If a crack is found the propeller must be replaced immediately. If corrosion pits (the tiny black dots) are discovered they must be removed within the next 20 hours of operation. They can be removed in the following manner: (1) Sand the area with 220 grit wet-or-dry abrasive paper and polish with 320 grit or finer. (2) Clean the area thoroughly and apply a dye penetrant. (3) Inspect with a low-power glass; it is very important that the bottom of the pits be completely removed. If the pits re-appear, repeat the operations. (4) When the pits are completely removed, spray the area with a clear lacquer.

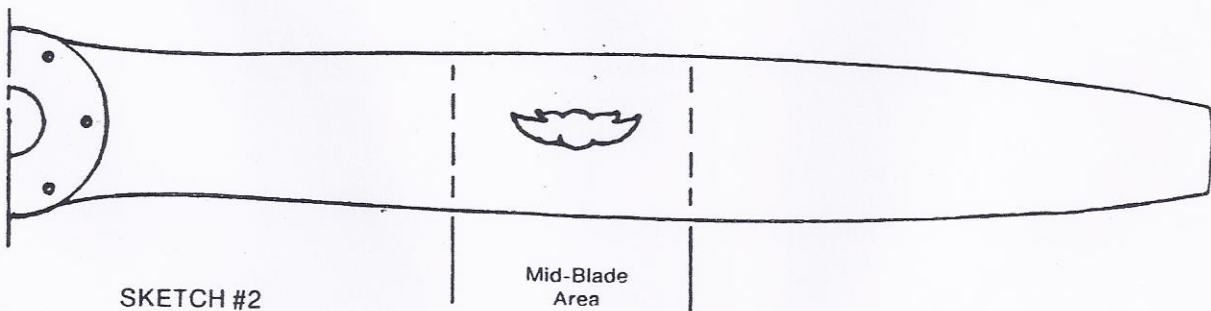
SKETCH #2

It now appears that some owners, when attempting to comply with Bulletin R-10, were looking for a white powdery corrosion and failed to notice the small black dots. The new style epoxy adhesive decal was then installed over these corrosion pits. For this reason, and to ensure that all propellers are properly inspected, the mid-blade decals must be removed. The decals should be soaked with paint remover and rubbed off with a rag; they must not be scraped or sanded off. The mid-blade area (sketch #2) must be thoroughly re-inspected with a glass of approximately 3 power.
