SERVICE LETTER NO. 76-2
"FAA DOA EA-4 APPROVED"

DATE: February 16, 1976
SUBJECT: VENDOR SERVICE PUBLICATIONS
SERIALS AFFECTED: All Model AA-1, AA-1A, AA-1B, AA-5, AA-5A and AA-5B.
TIME OF COMPLIANCE: As indicated in each publication.

Service Bulletin No. 385C
(Supersedes Service Bulletin No. 385B)
Engineering Aspects are
FAA (DEER) Approved

SUBJECT: Oil Pump Impeller and Drive Replacement

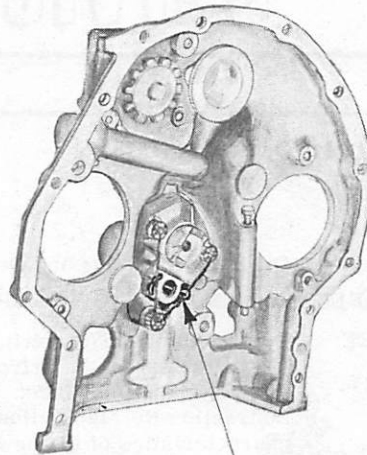
Figure 1. Interior View of Accessory Housing Showing Location of Cotter Pin in Oil Pump Idler Shaft

INSPECTION: Applicable remanufactured engines shipped after December 21, 1972 should be inspected to determine if this modification is required: first of all, if the engine log book indicates the engine has not been modified in accordance with Service Instruction No. 1230 or No. 1272, proceed to remove the accessory drive cover from the mounting pad at the lower right side of the accessory housing to obtain access to the area between the crankcase and the accessory housing. On some engines this accessory drive pad is not machined, in this event it will be necessary to remove either the left magneto or the *fuel pump to obtain access to the area between the crankcase and the accessory housing. Regardless of which accessory pad is used, determine if the oil pump idler gear is secured with a cotter pin at the location shown in figure 1. This can be accomplished using an inspection mirror, preferably an illuminated one. If the cotter pin is visible, it is unnecessary to perform the modification required by this bulletin.

IF IDLER SHAFT IS SECURED WITH A COTTER PIN AT THIS LOCATION MODIFICATION IS NOT REQUIRED

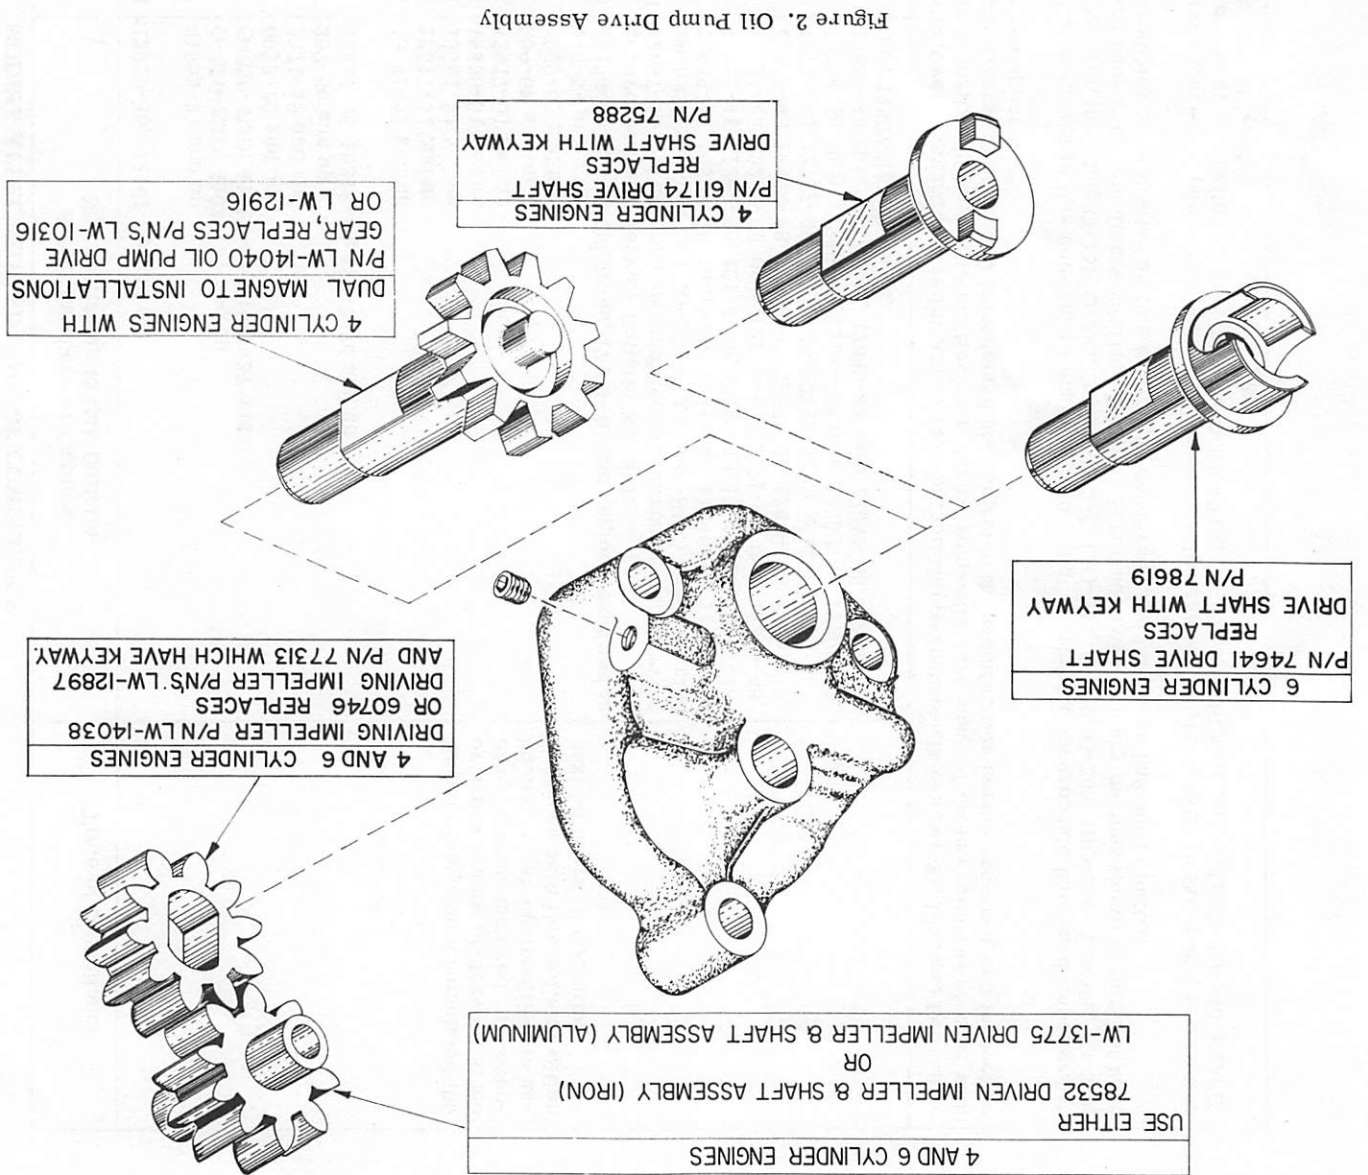
Figure 2. Oil Pump Drive Assembly

This modification consists of replacing the oil pump drive shaft and drive impeller to eliminate the Woodruff key drive which has proven to be the cause of excessive wear in the keyway of the hardened drive impeller. Therefore, it is recommended that all of the applicable engines listed in the chart, as well as any others that may have been modified in accordance with Service Instruction No. 1272, use the following procedure for parts replacement.

3. Reassemble the oil pump using the new drive shaft and drive impeller supplied with the kits shown in the following "Parts Data" section. See figure 2. Be sure all of the parts are lubricated thoroughly during assembly.
