GRUMMAN AMERICAN AVIATION CORPORATION
SAVANNAH, GEORGIA

STANDARD REPAIR MANUAL

MODEL ALL LIGHT A/C : REPORT NO. LIÁ S.R. 002

REPORT DATE: FEB. 1, 1978

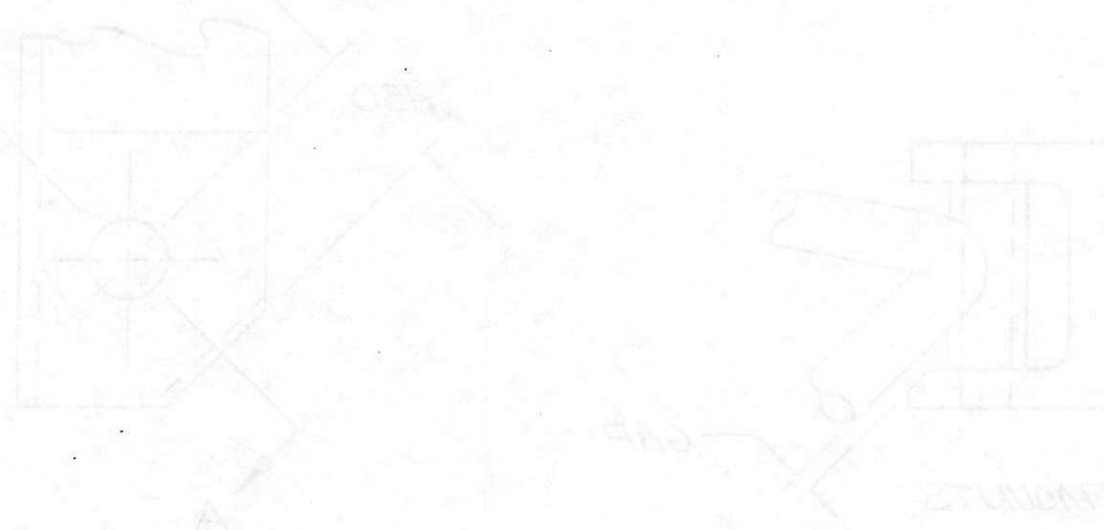
OVERLAPPING FLANGES

REPAIR: Trim portion of overlapping member to obtain a resulting edge gap of .03 to .06 or to clear bend tangent by .03 to .06. Use smooth edge trim and runout of .50 min.
